July 31, 2020  
Wood Project No.: ET200020

**Reference: Lindbrook Estates Subdivision  
Drainage Assessment Report  
Beaver County**

**June 20, 2020 Site Visit Photos**

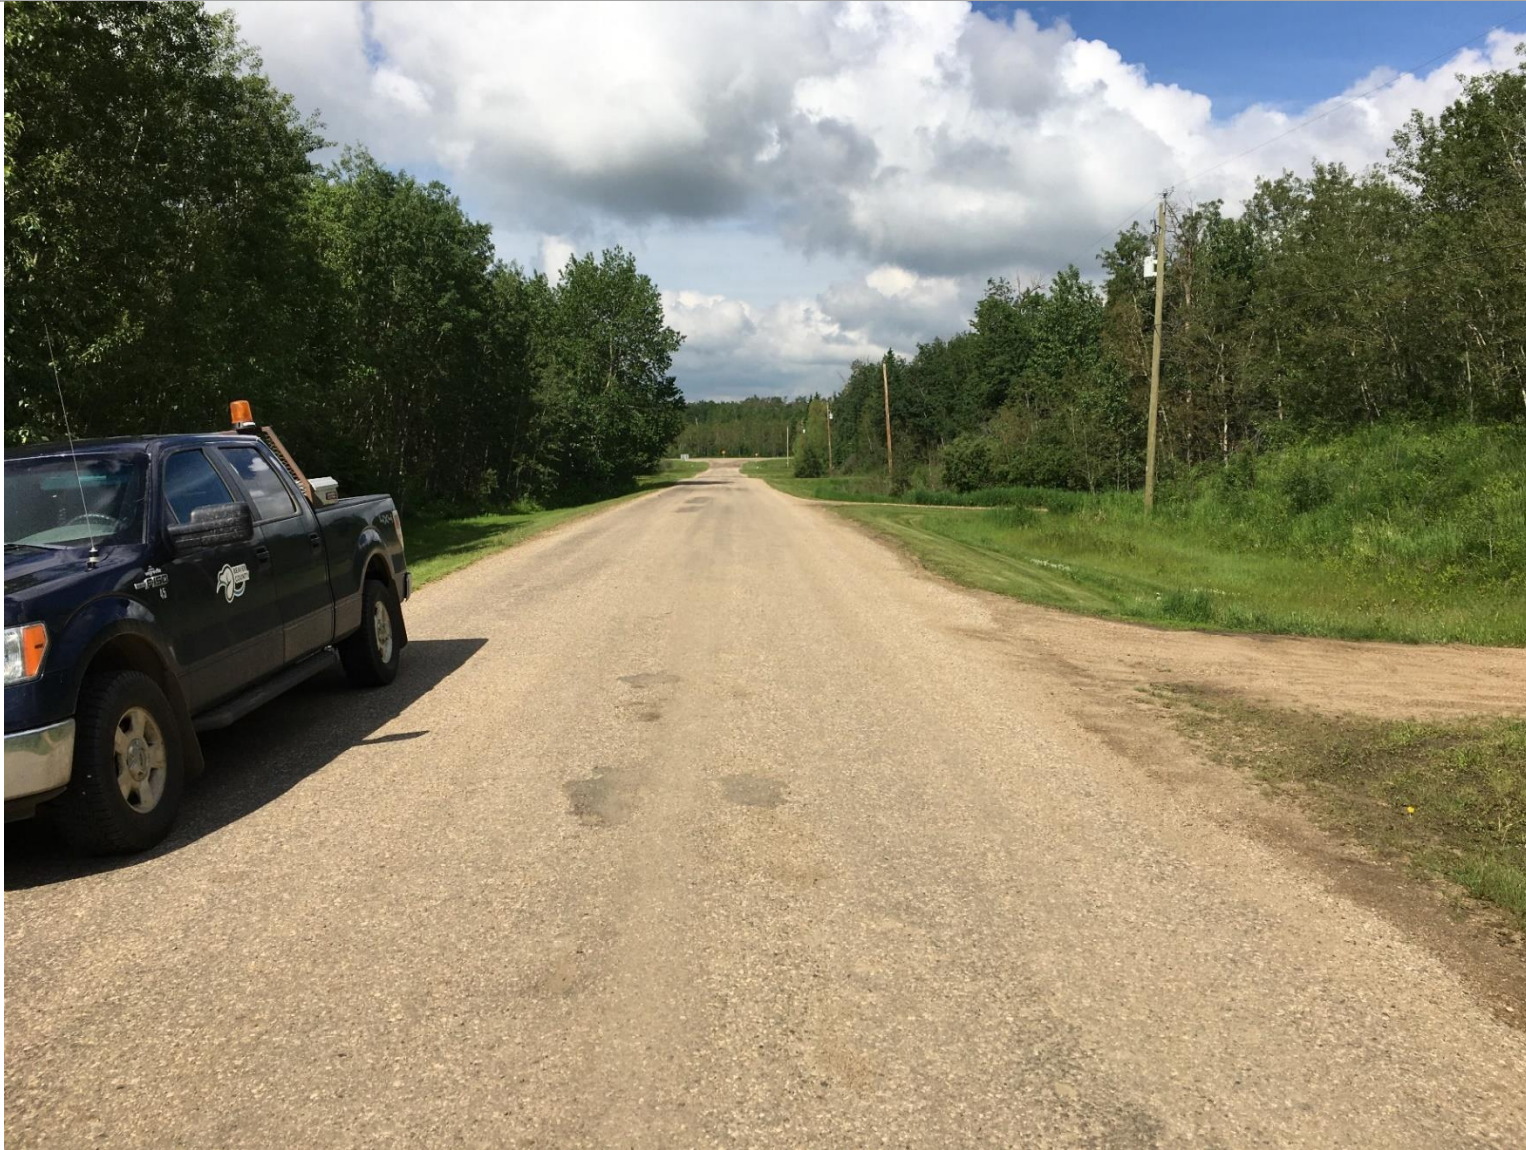
Photo 1

Beaverhill Drive  
looking west in  
vicinity of Lots  
#18, #24 and  
#30.

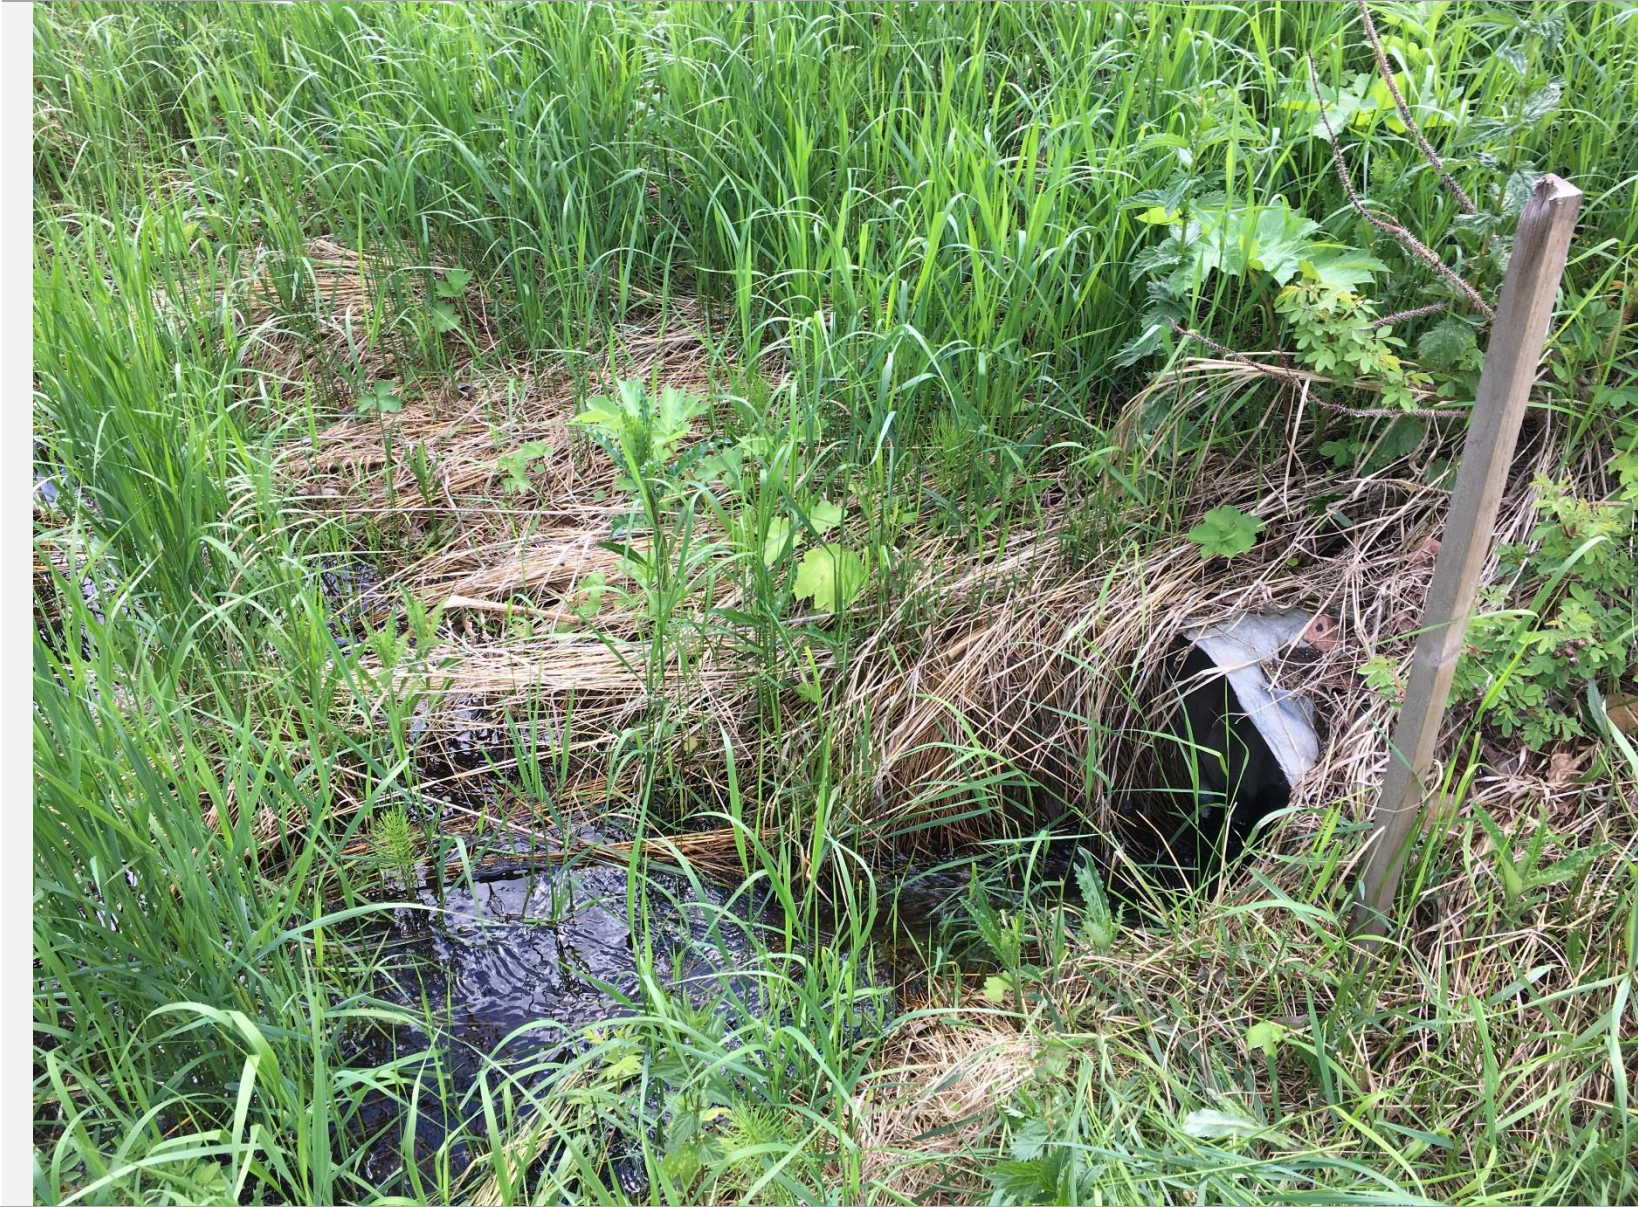
**Photo 2**

- Site 5 - Site 5 survey provides the roadway profile and CL culvert inverts draining from north to

- south into MR. The 600mm diameter X 17 m CSP culvert invert elevations are; N Inv 724.28 and S Inv 723.93.
- Site 4 - Site 4 survey provides a plan and profile along the hose (being used for pumping of water) from MR (Lot 4) through Lot 5 into Lot 6 and Lot 11 existing natural drainage path. Site 4 profile shows that the ponded water level in MR is 722.37 and in the natural drainage path in Lot 11 it is 720.29. This provides a slope of 1.7%. The profile also shows high ground between MR (Lot 4) and Lot 5 at an elevation in the order of 723.1, which provides a berm height in the order of 0.9 m between the two properties. The water is currently being held back at the property line between Lot 5 and the MR (Lot 4).

600 mm CSP under Beaverhill Drive culvert inlet draining into MR (Lot #24), surveyed site 5.

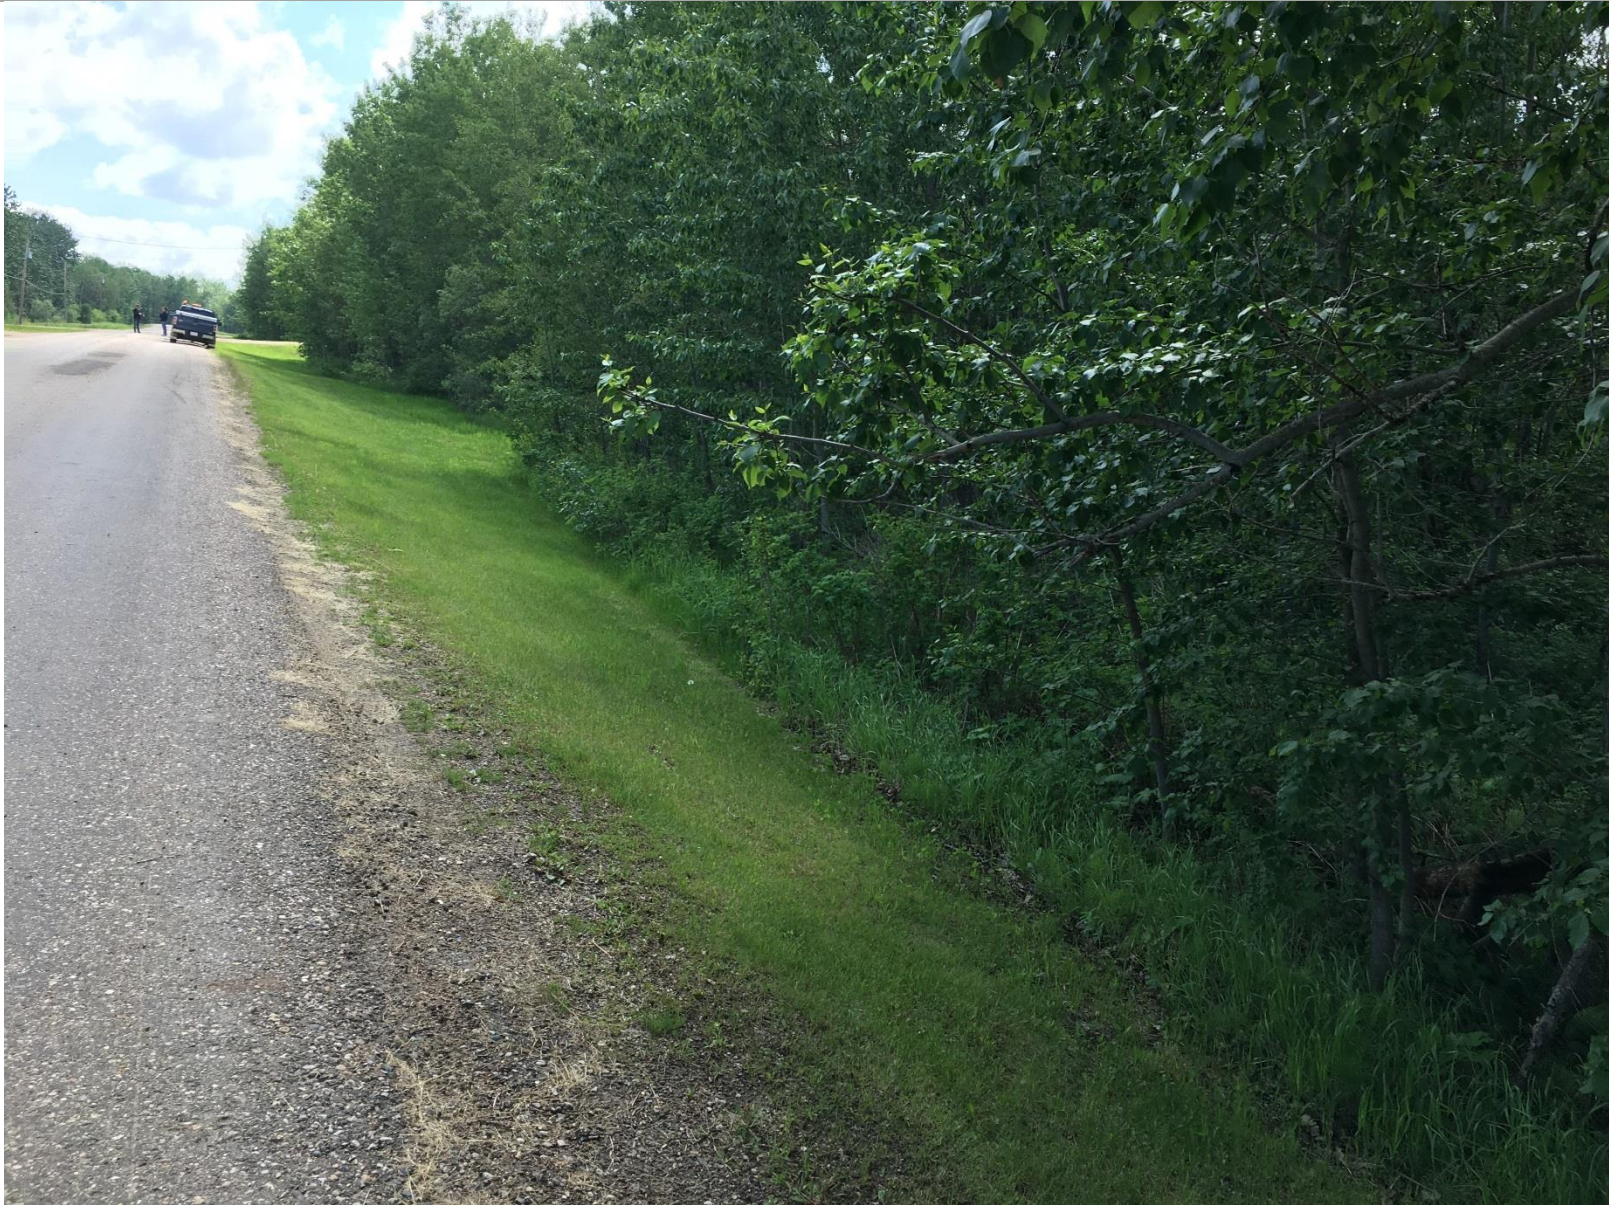
**Photo 3**

Looking east along Beaverhill Drive south ditch adjacent to MR (Lot #24).

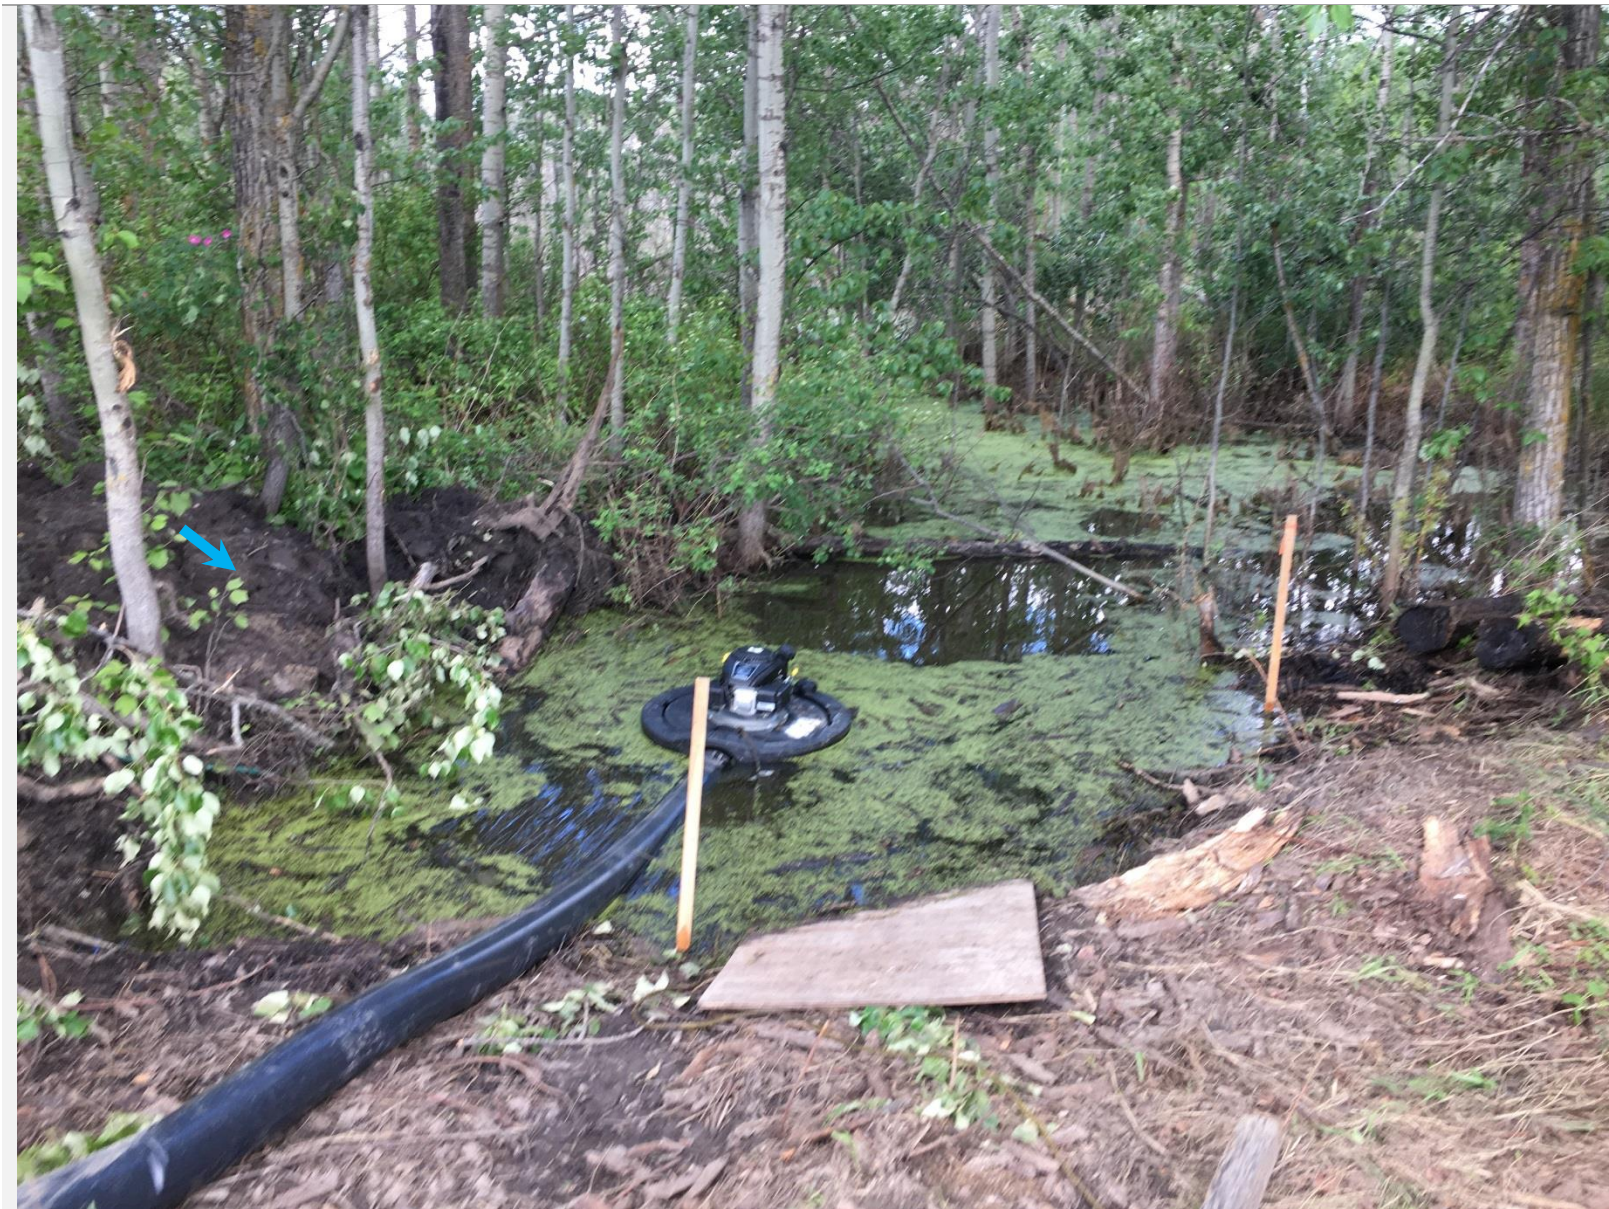
**Photo 4**

Wood, along with the County, carried out Lindbrook Estates site visit on June 20, 2020. Site visit photos are included in Appendix A. Culverts, ditches and 2020 drainage water flood impacted areas were inspected. It was noted that the drainage water from MR Lot 4 in Block 2 (Lot #24) was being pumped to the existing natural drainage path in Lot 6 of Block 2 (Lot #36) through a hose. The historical drainage path from the MR was blocked by the development in Lot 5 of Block 2 (Lot #30). Wood was unable to find any evidence of a culvert/pipe across Lot 5 of Block 2 (Lot #30) to convey drainage water from MR to Lot 6 of Block 2 existing natural drainage path.

Looking west at pump to divert water from MR (Lot #24) to lot #36 in existing natural drainage ditch (surveyed site 4).

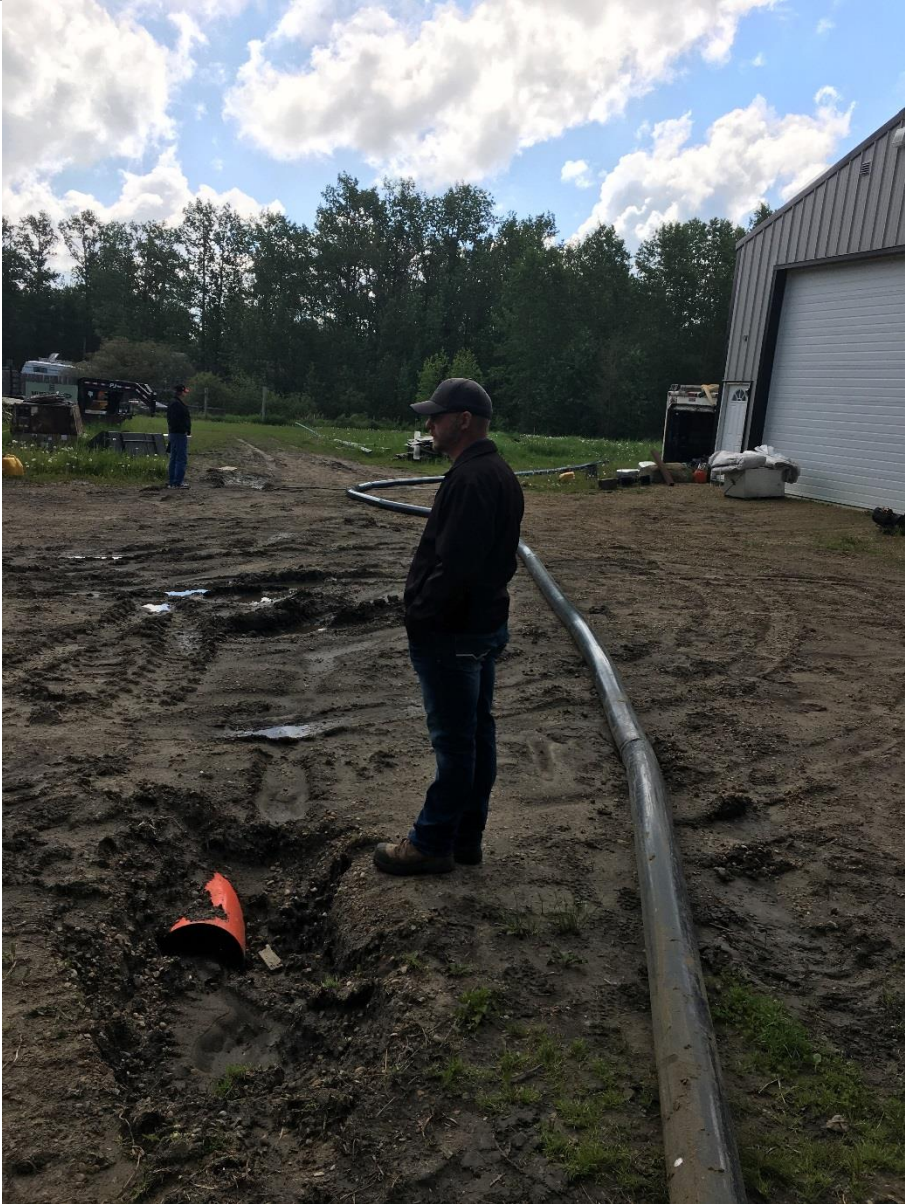
**Photo 5**

Looking east at water hose to divert water from MR (Lot #24) to Lot #36. Hose is installed within Lot #30 (surveyed site 4).

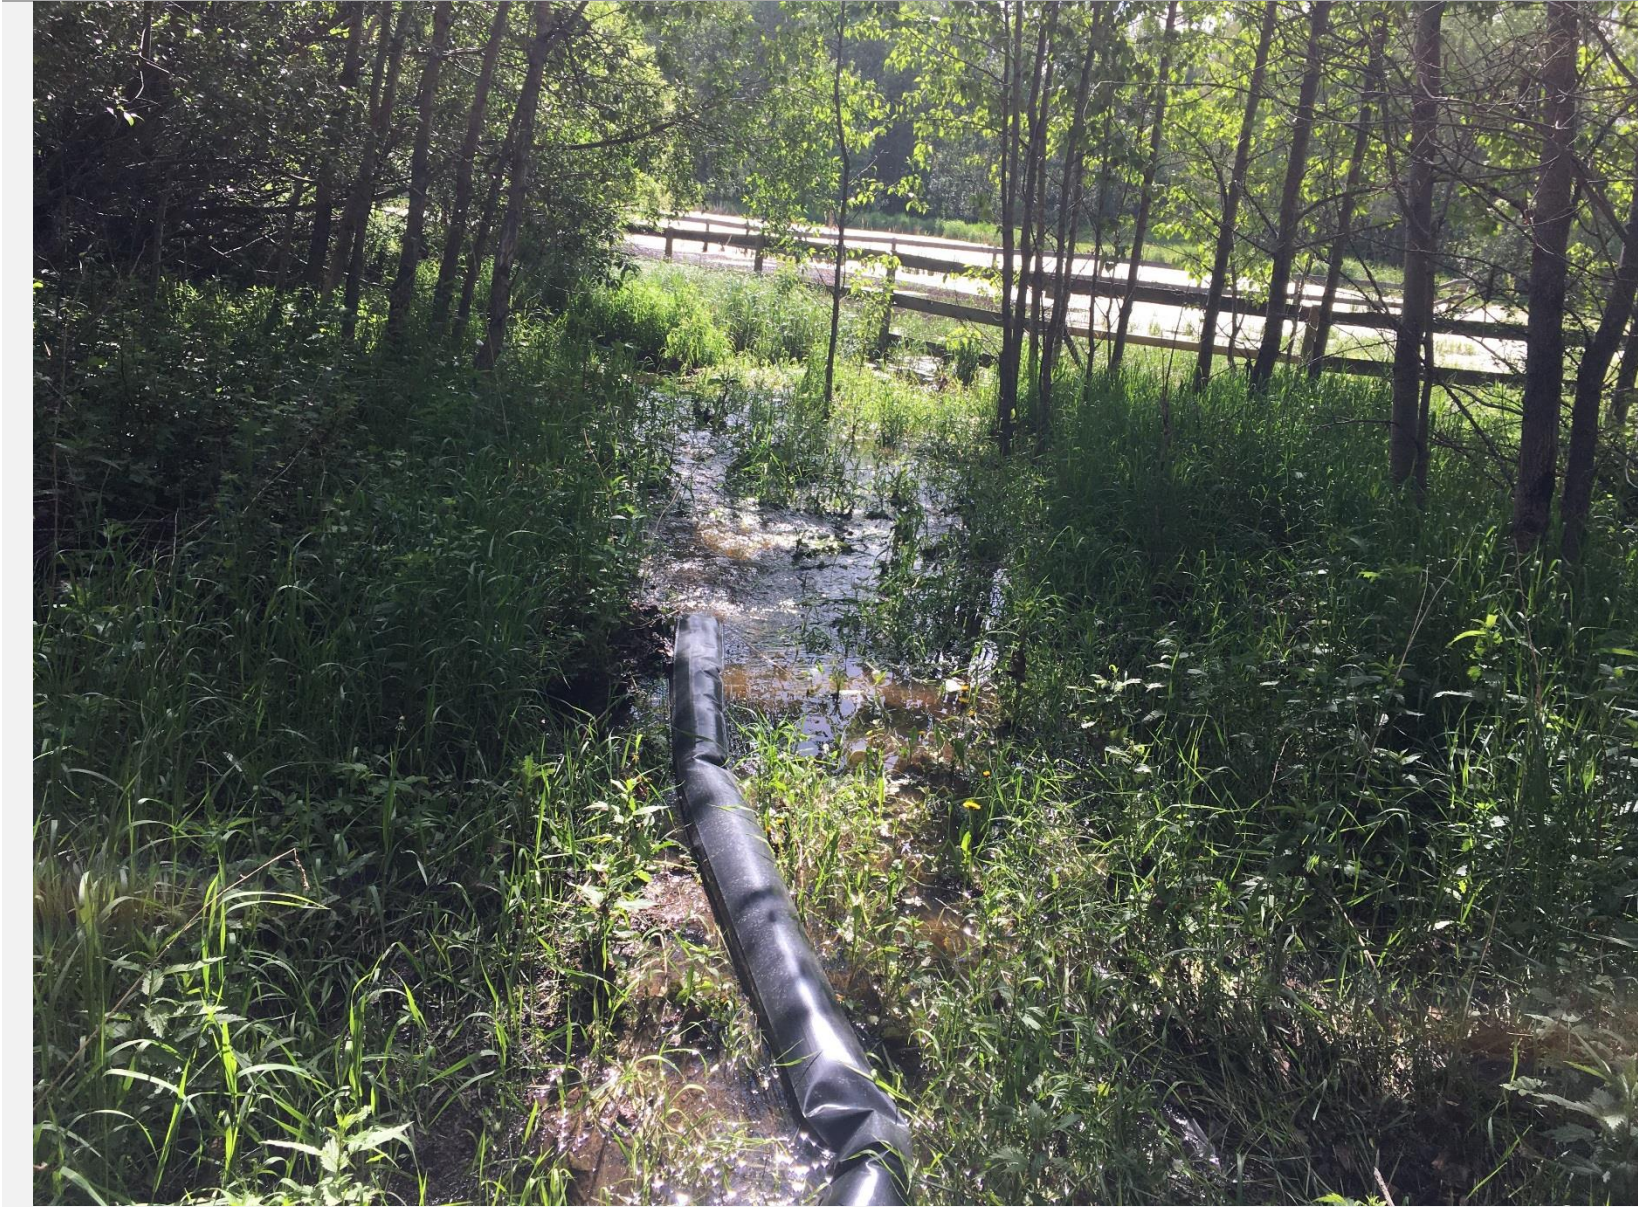
**Photo 6**

Looking southeast at water hose diverting water from MR (Lot #24) to natural channel in Lot #36 (surveyed site 4).

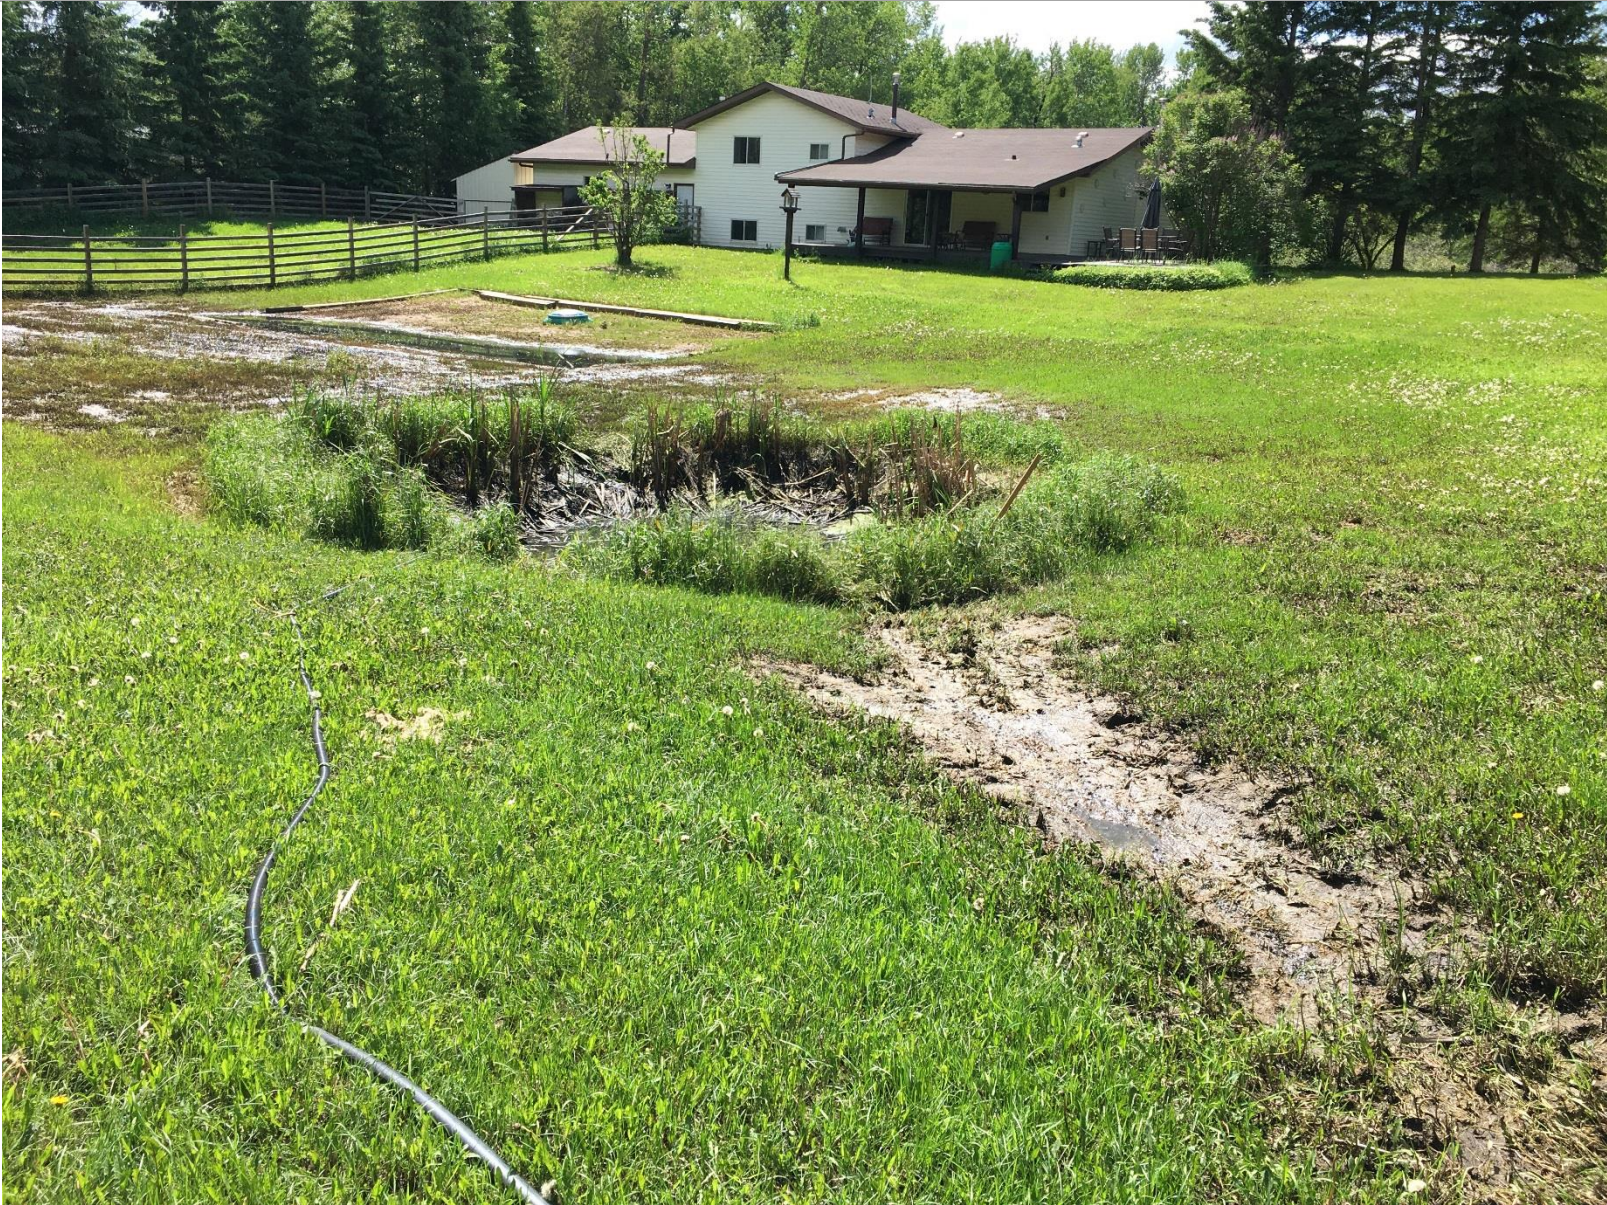
As shown on the plan given in Appendix D provided by the County, the existing drainage pattern is from the north to the internal subdivision road and through a CL culvert to the south to MR at site 5. Due to 0.9 m high berm between MR (Lot 4) and Lot 5, the water is ponded in MR and backs up across the west side of the MR Lot 4 (Lot #24) and onto Lot 3 (Lot #18). Based on our review of historical air photos, the water should flow east across the south side of the MR Lot 4 (Lot #24) and across Lot 5 (Lot #30) to the existing natural drainage channel in Lot 6. Presently during high flooding due to excessive rains, drainage water is diverted to the existing natural drainage path in Lot 6 through a pump and hose arrangement from where that drainage path runs east to the internal subdivision road again. From there, it runs south through one approach, under the road and down to the cul-de-sac at the south east end of the subdivision before running under Township (TWP) Road 512 and south to the Hastings Creek.

**Photo 7**  
Flooding of lot south of MR (Lot #24).

It is recommended to proceed with the detail design of Option 1 (i.e. construct a drainage ditch from MR (Lot 4) to natural drainage path in Lot 6 through Lot 5 along the historical drainage path) since Option 1 would provide the shortest drainage path along the historical natural drainage path with the smallest footprint than Option 3. Option 1 is also preferred over Option 2 since its maintenance would be easier. An agreement with the current landowner would be required for the recommended Option 1.

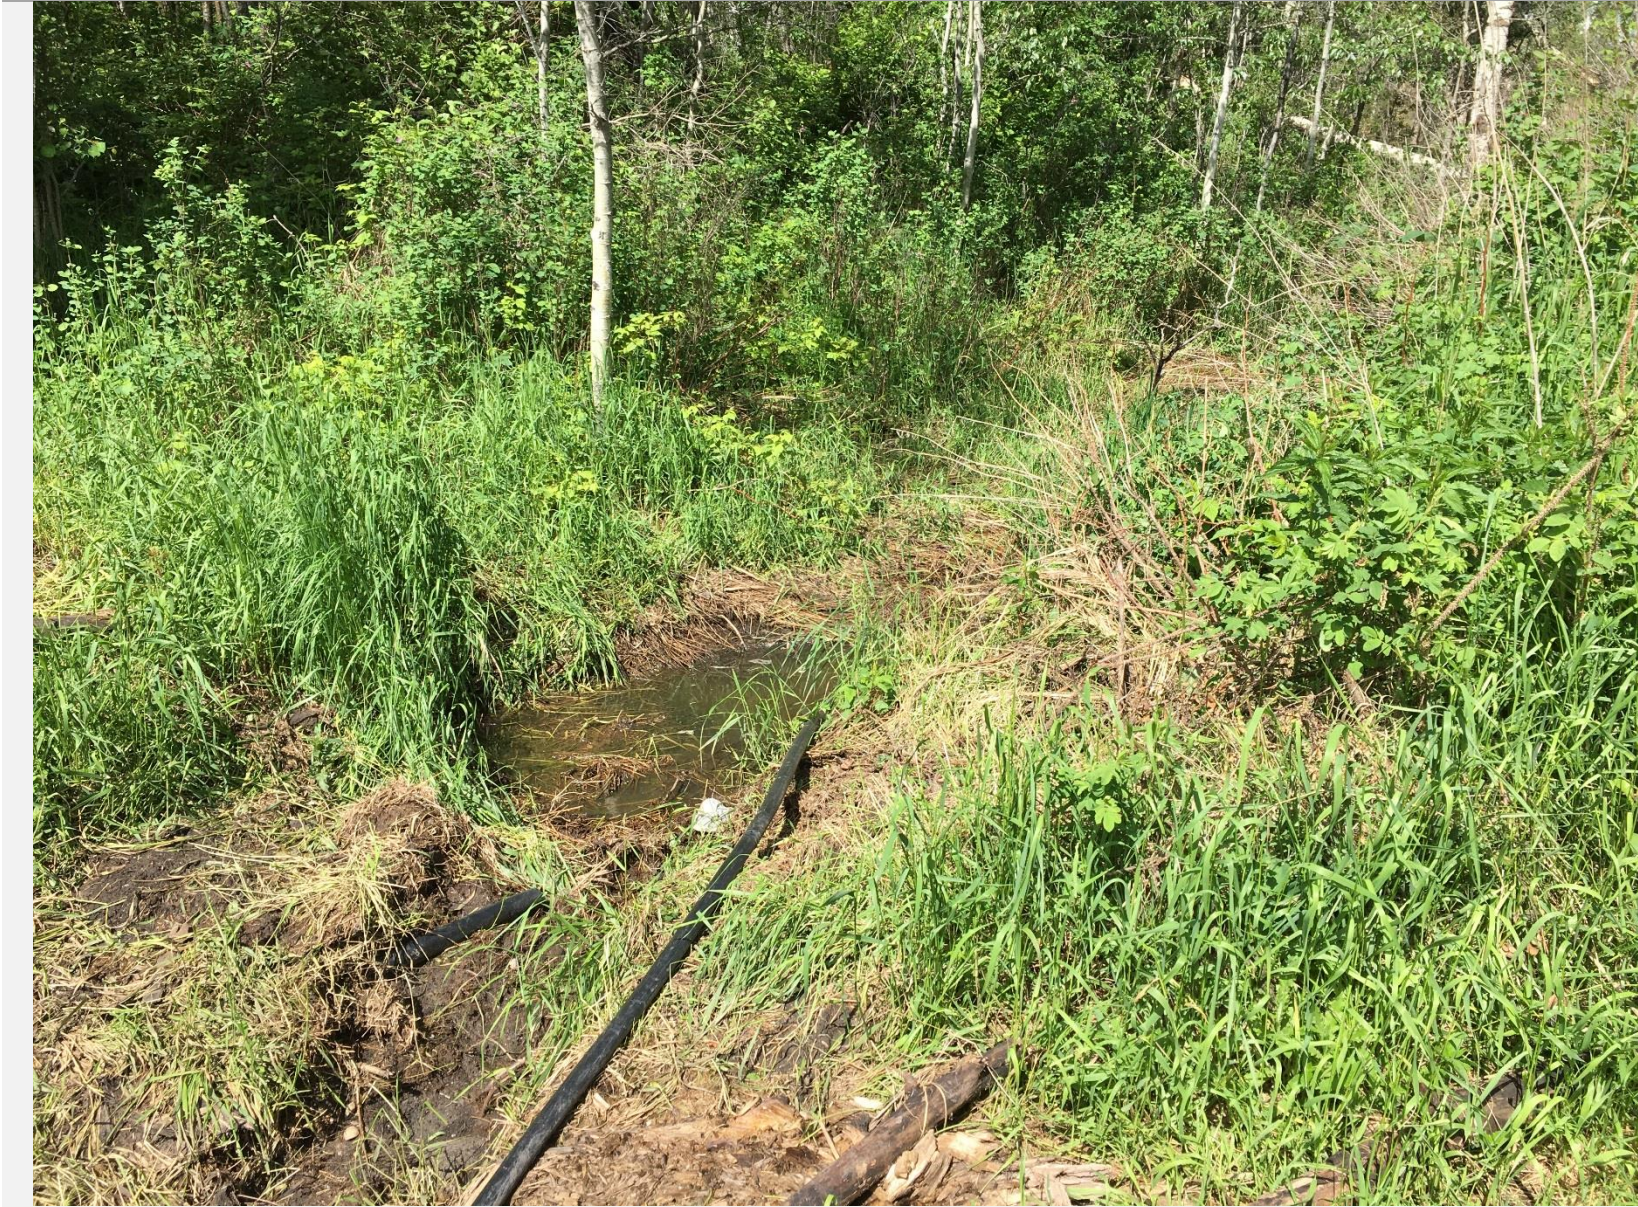
**Photo 8**

Looking northwest at hose diverting stormwater from lot south of MR to MR.

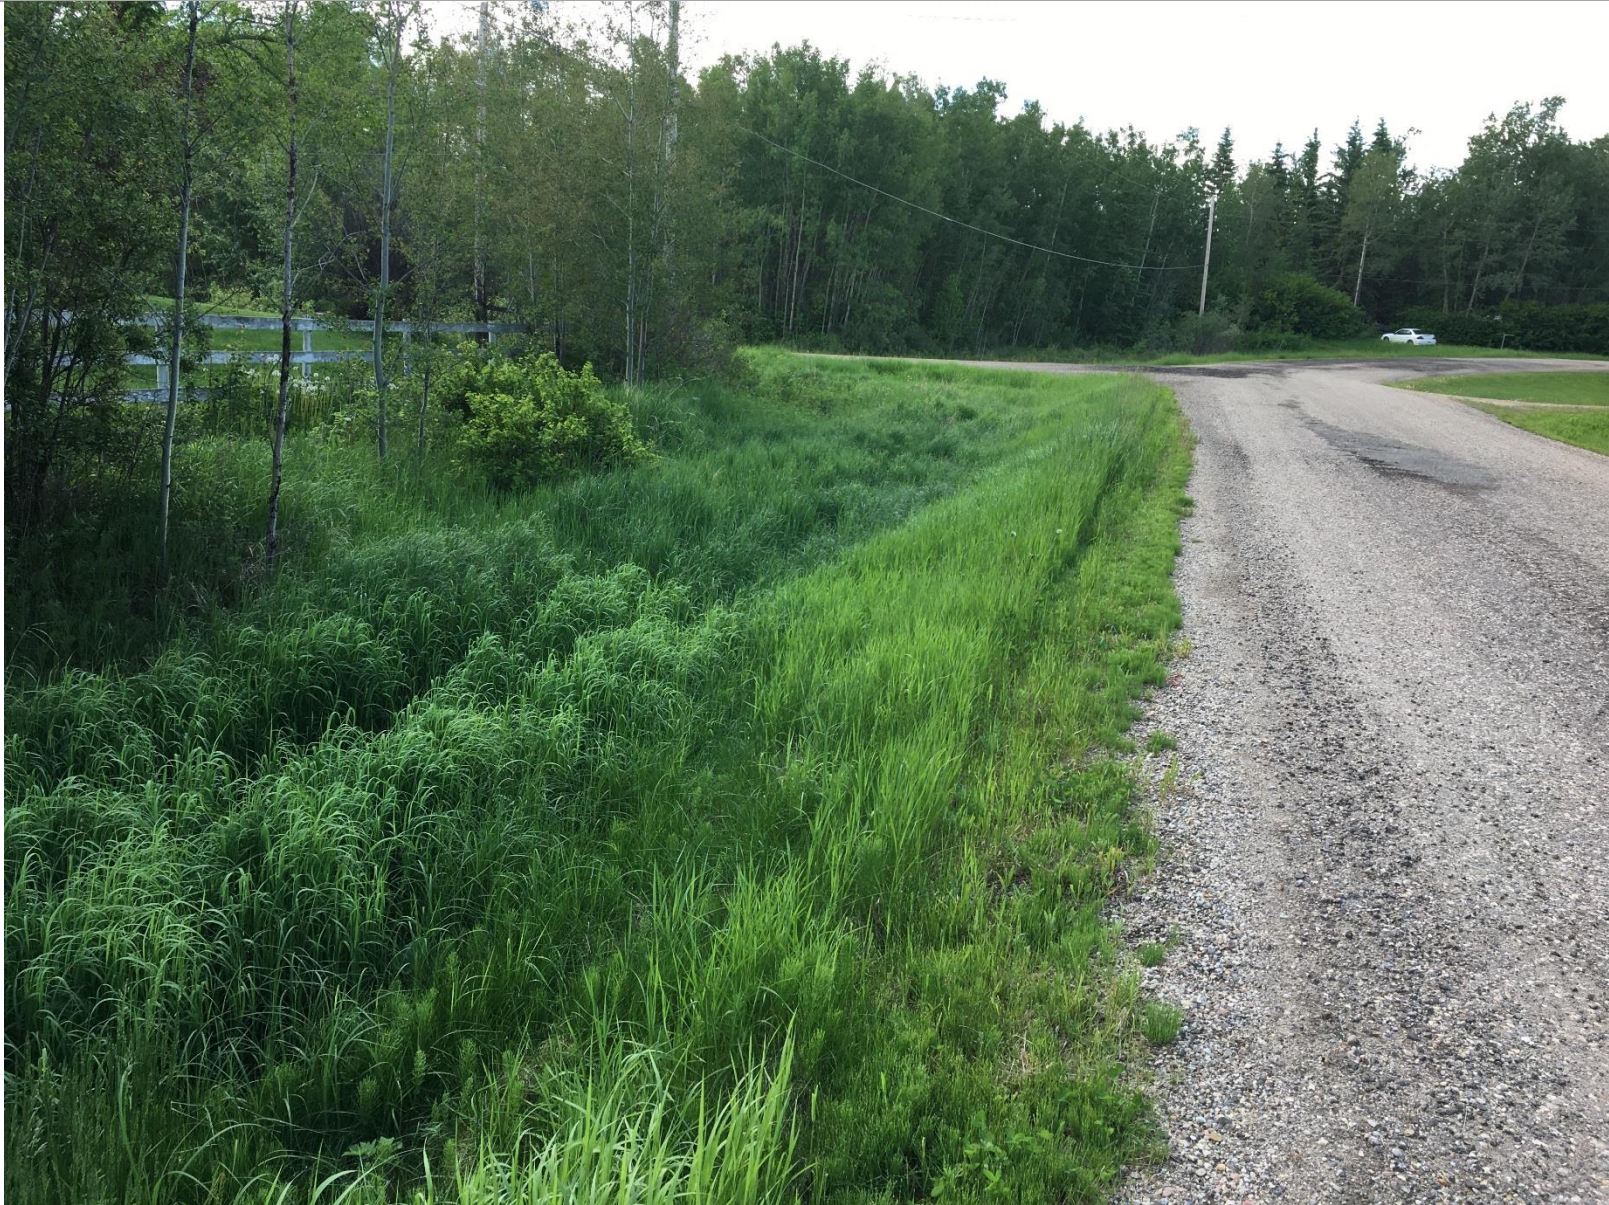
**Photo 9**

The drainage system from the surveyed site 2 downstream up to the surveyed site 1 (400 mm in diameter culvert under TWP Road 512) including ditches, CL culverts and approach culverts are not functioning well and should be further investigated. In general, in these areas, clearing, repair of blocked/damaged culverts and clearing and regrading of the ditches is proposed to maintain drainage flow until further drainage

Looking southwest at ditch at surveyed site 2.

It is recommended to conduct adequate survey to design this proposed ditch to divert flows from MR Lot 4 through Lot 5 into the natural drainage path in Lot 6. It is also recommended to conduct detailed drainage assessment of the area from surveyed site 2 downstream up to surveyed site 1 (400 mm culvert under TWP Road 512) including ditches, CL culverts and approach culverts.

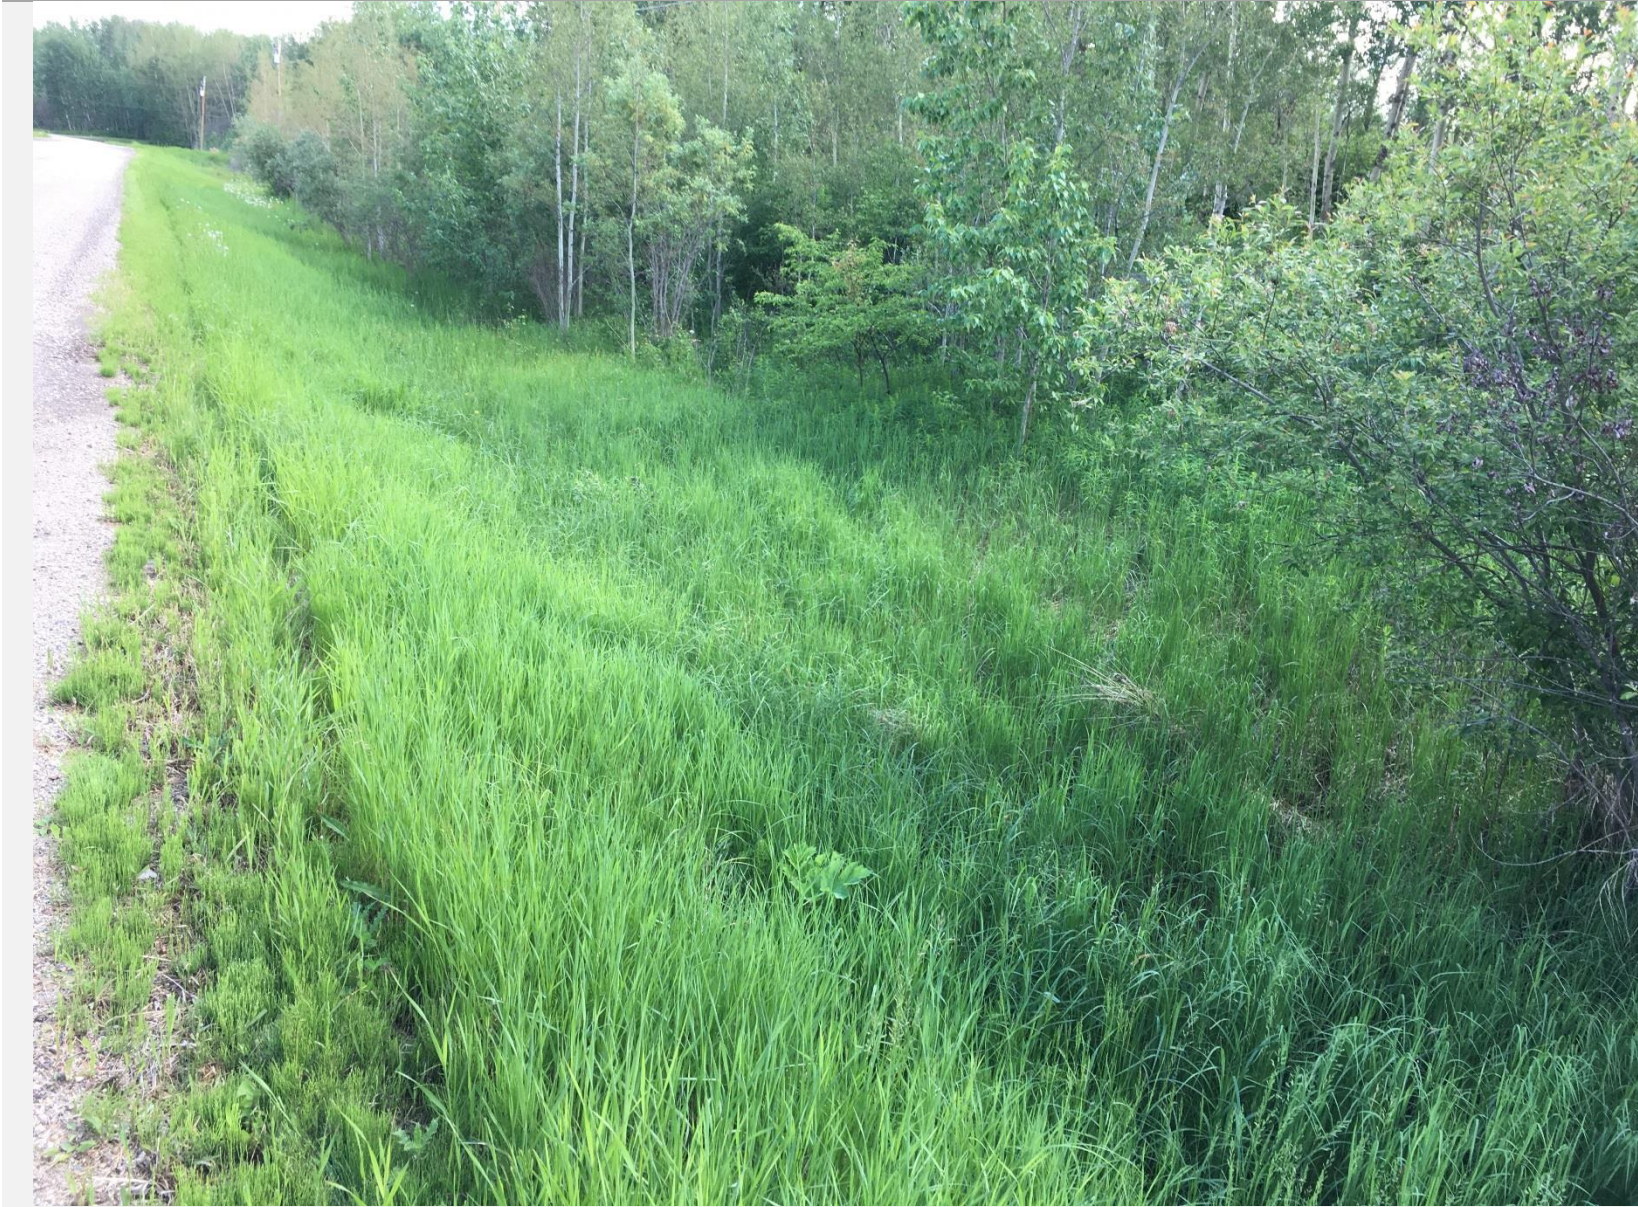
**Photo 10**

Looking northeast at ditch at surveyed site 2.

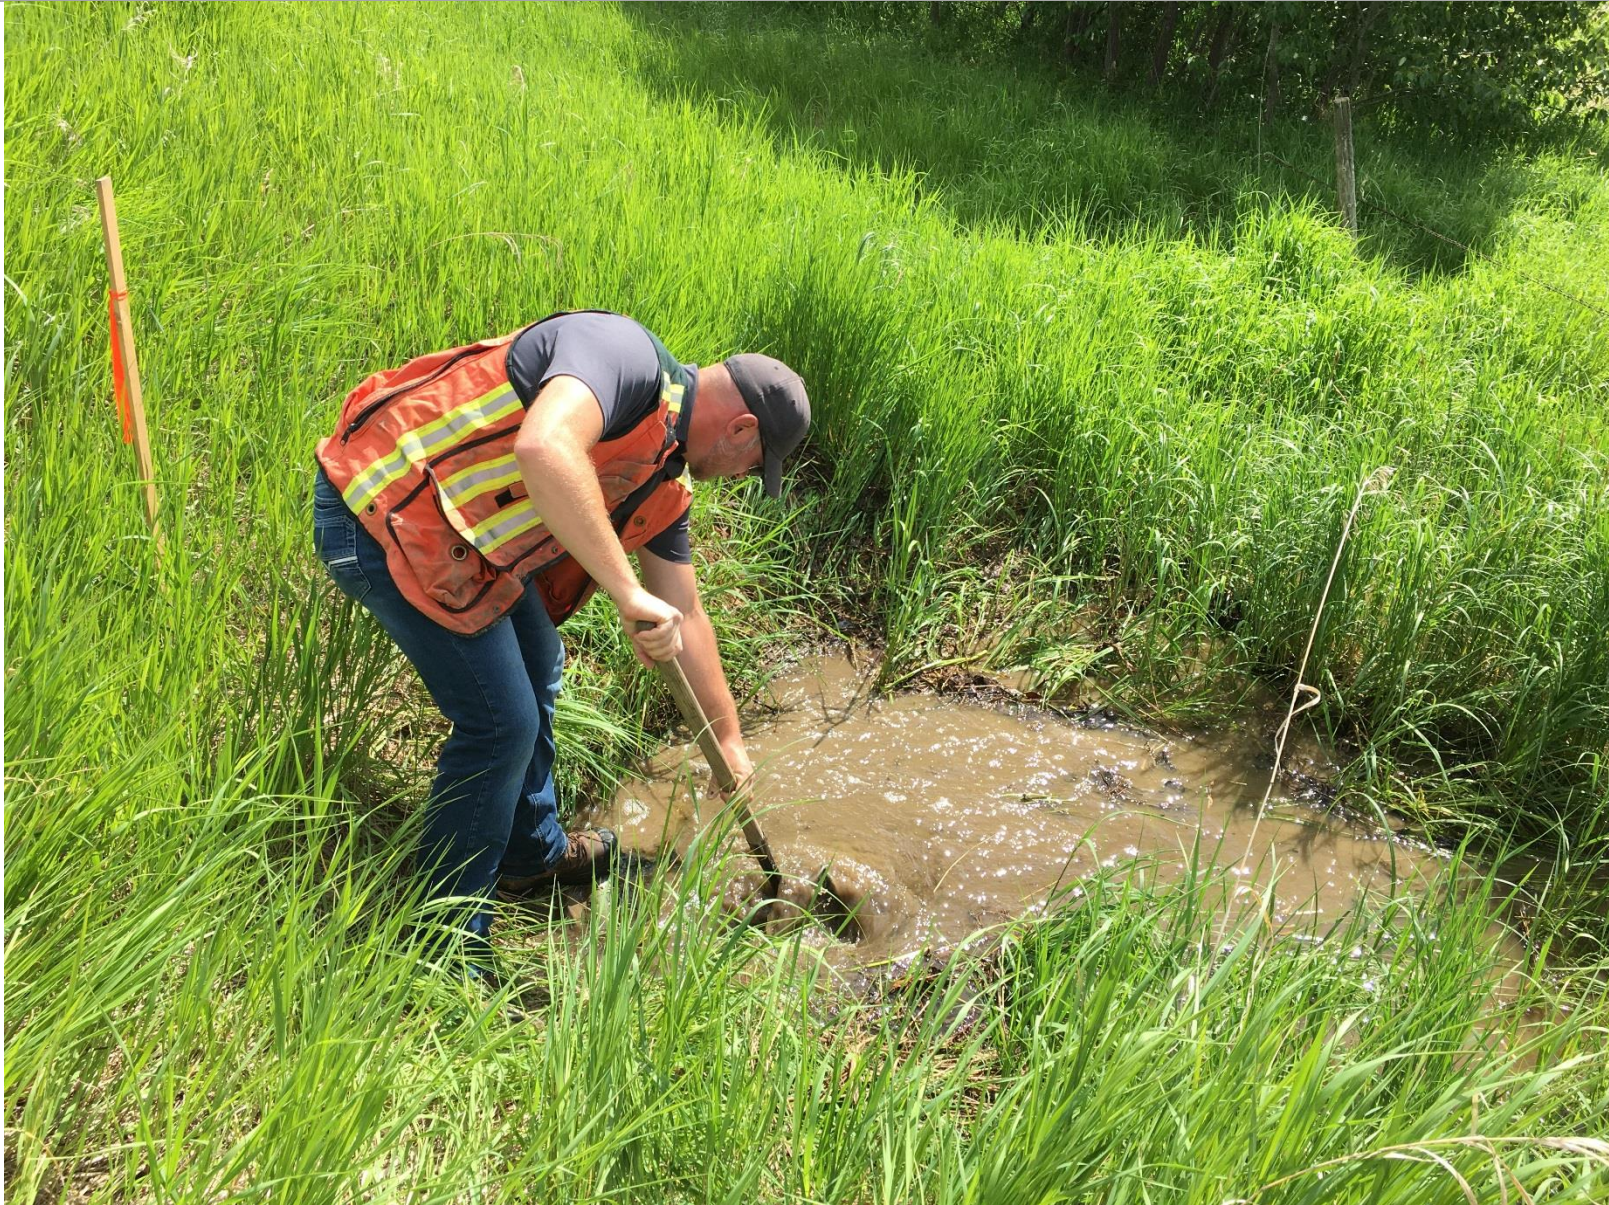
**Photo 11**

Looking at downstream invert (south) at 400 mm CSP culvert at surveyed site 1 under TWP Road 512.
