July 31, 2020  
Wood Project No.: ET200020

**Reference: Lindbrook Estates Subdivision  
Drainage Assessment Report  
Beaver County**

**June 20, 2020 Site Visit Photos**

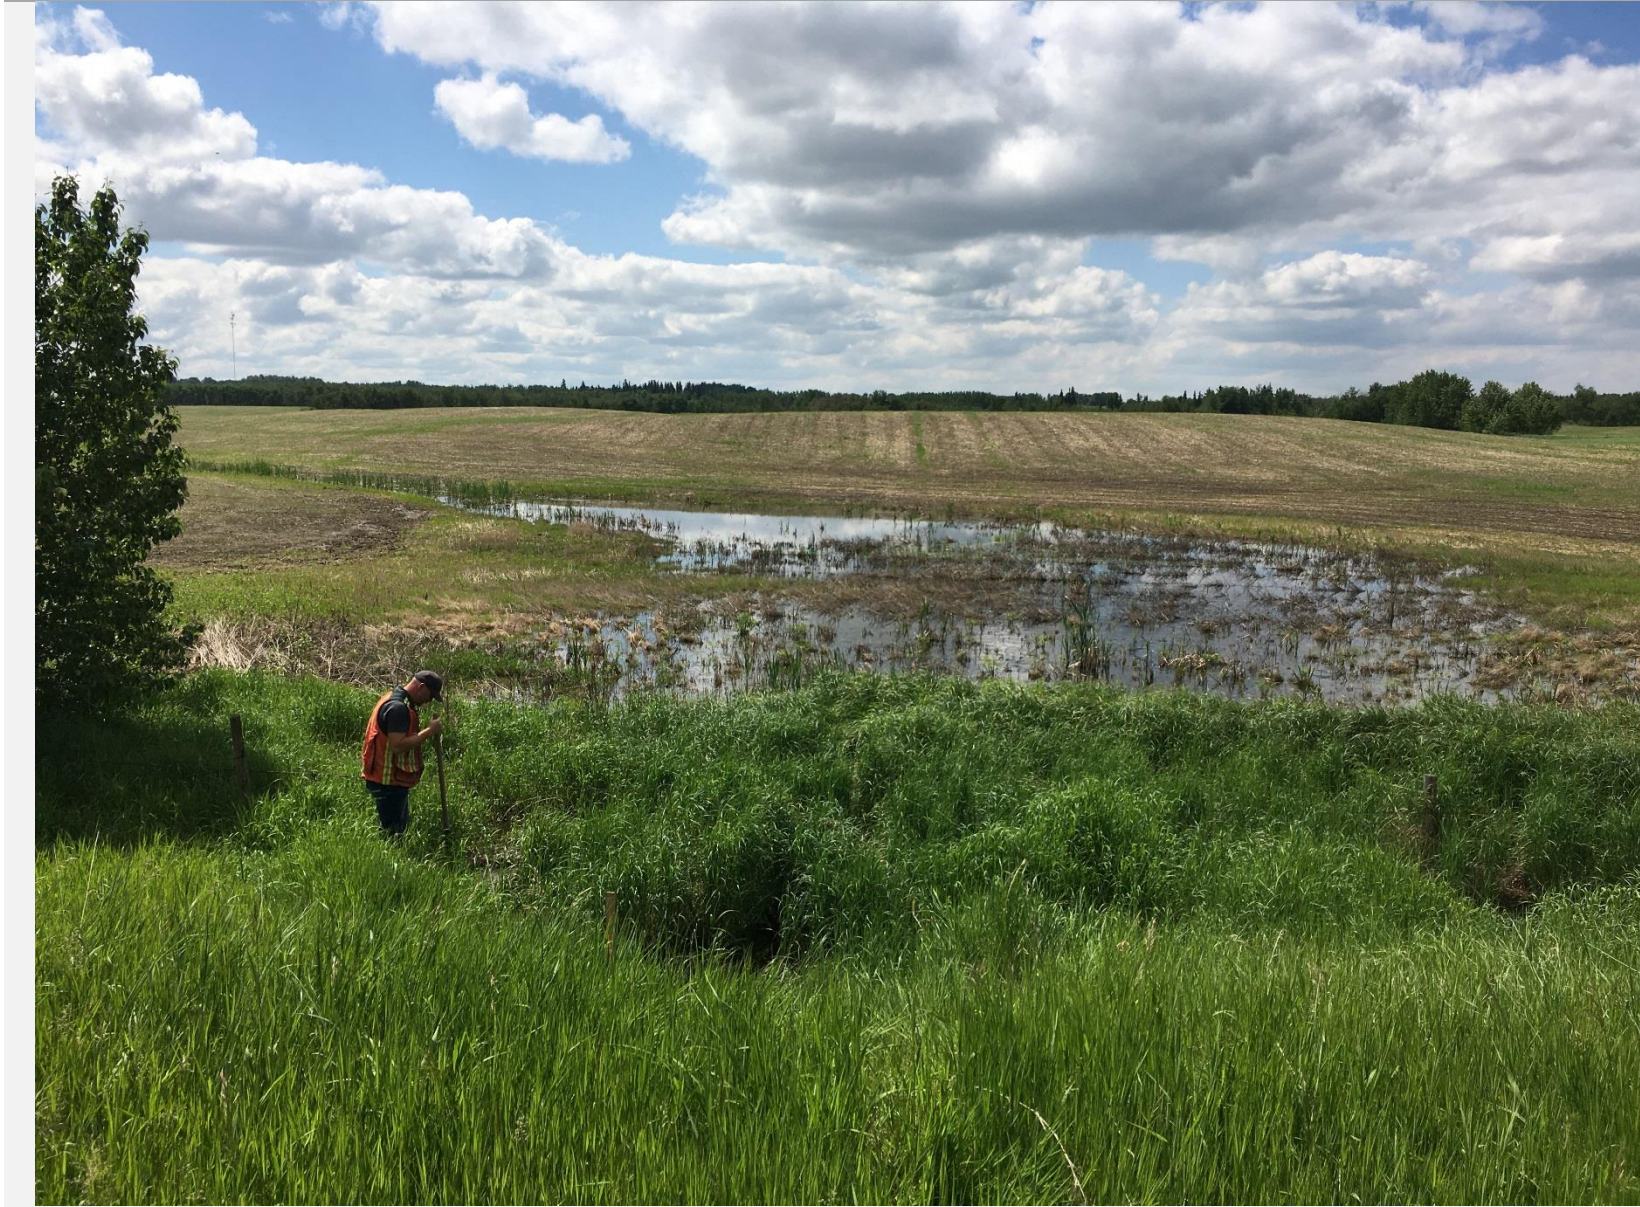
**Photo 12**

Looking south (downstream) of surveyed site 1 culvert under TWP Road 512.

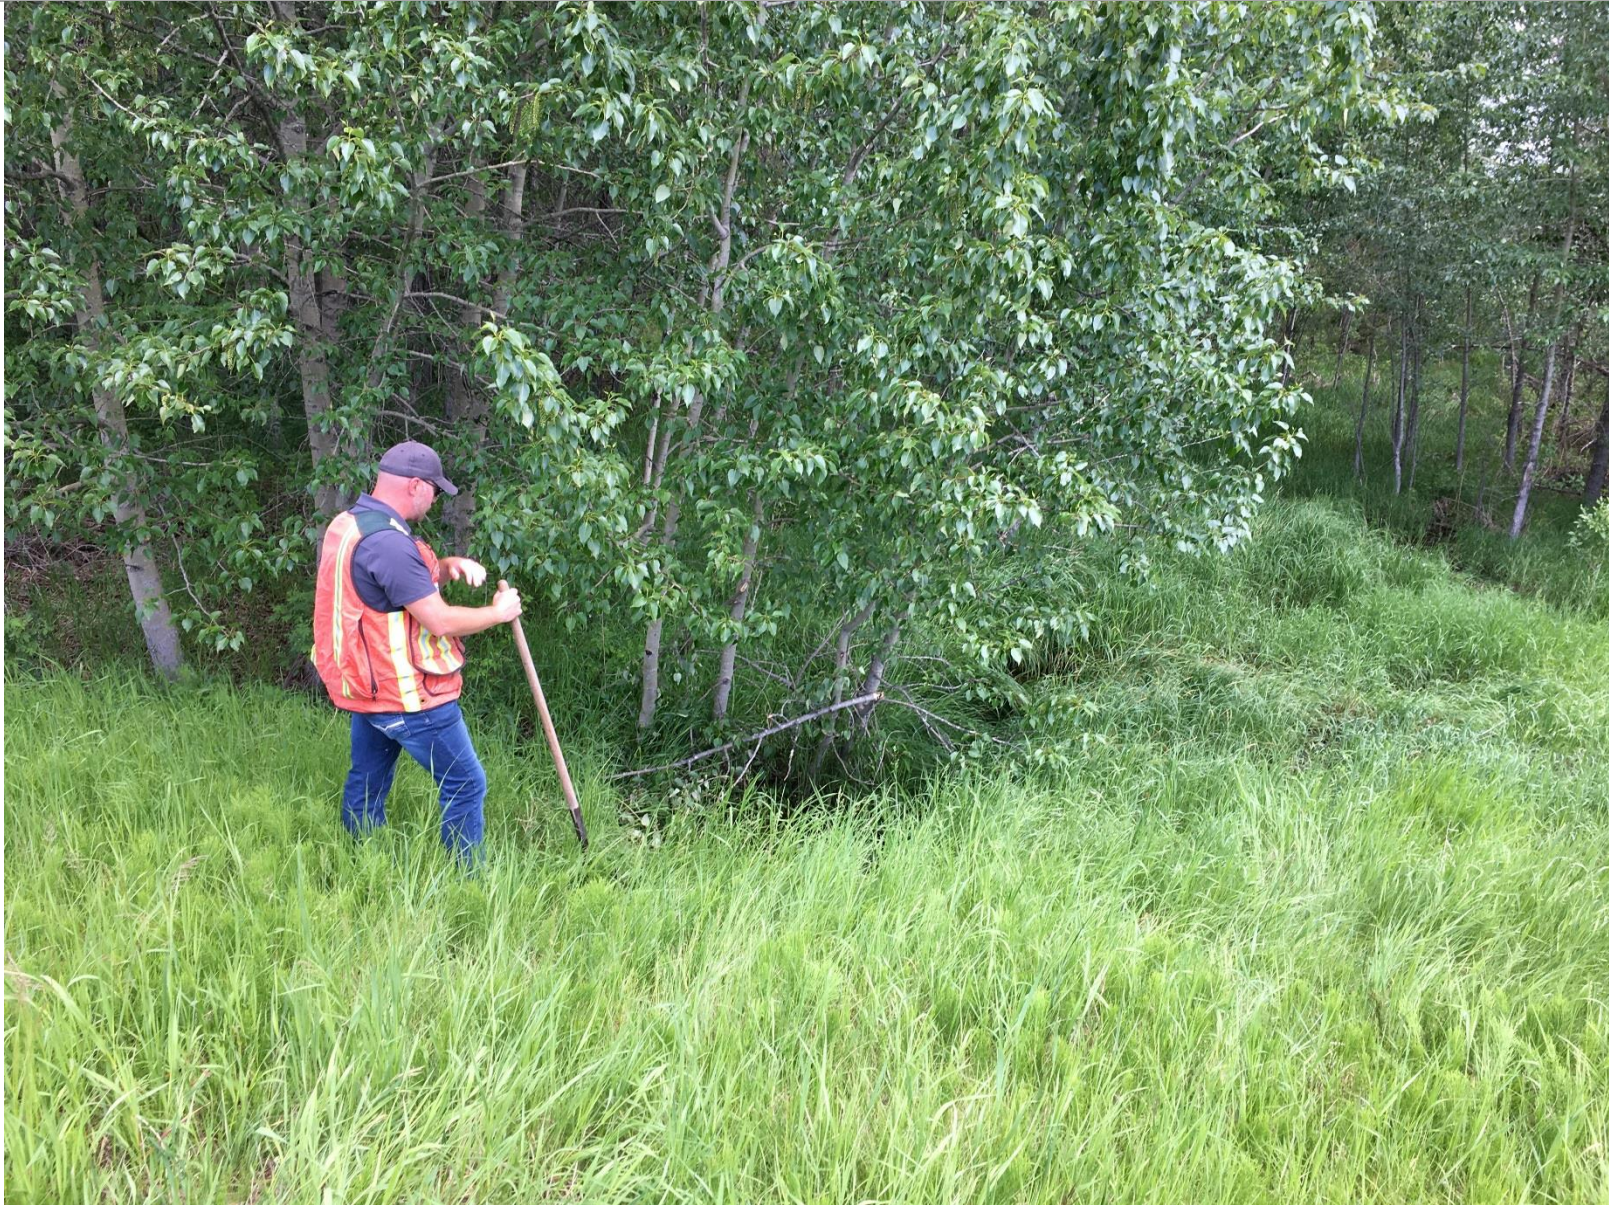
**Photo 13**

Looking north  
(upstream ) of  
culvert under  
TWP Road 512.

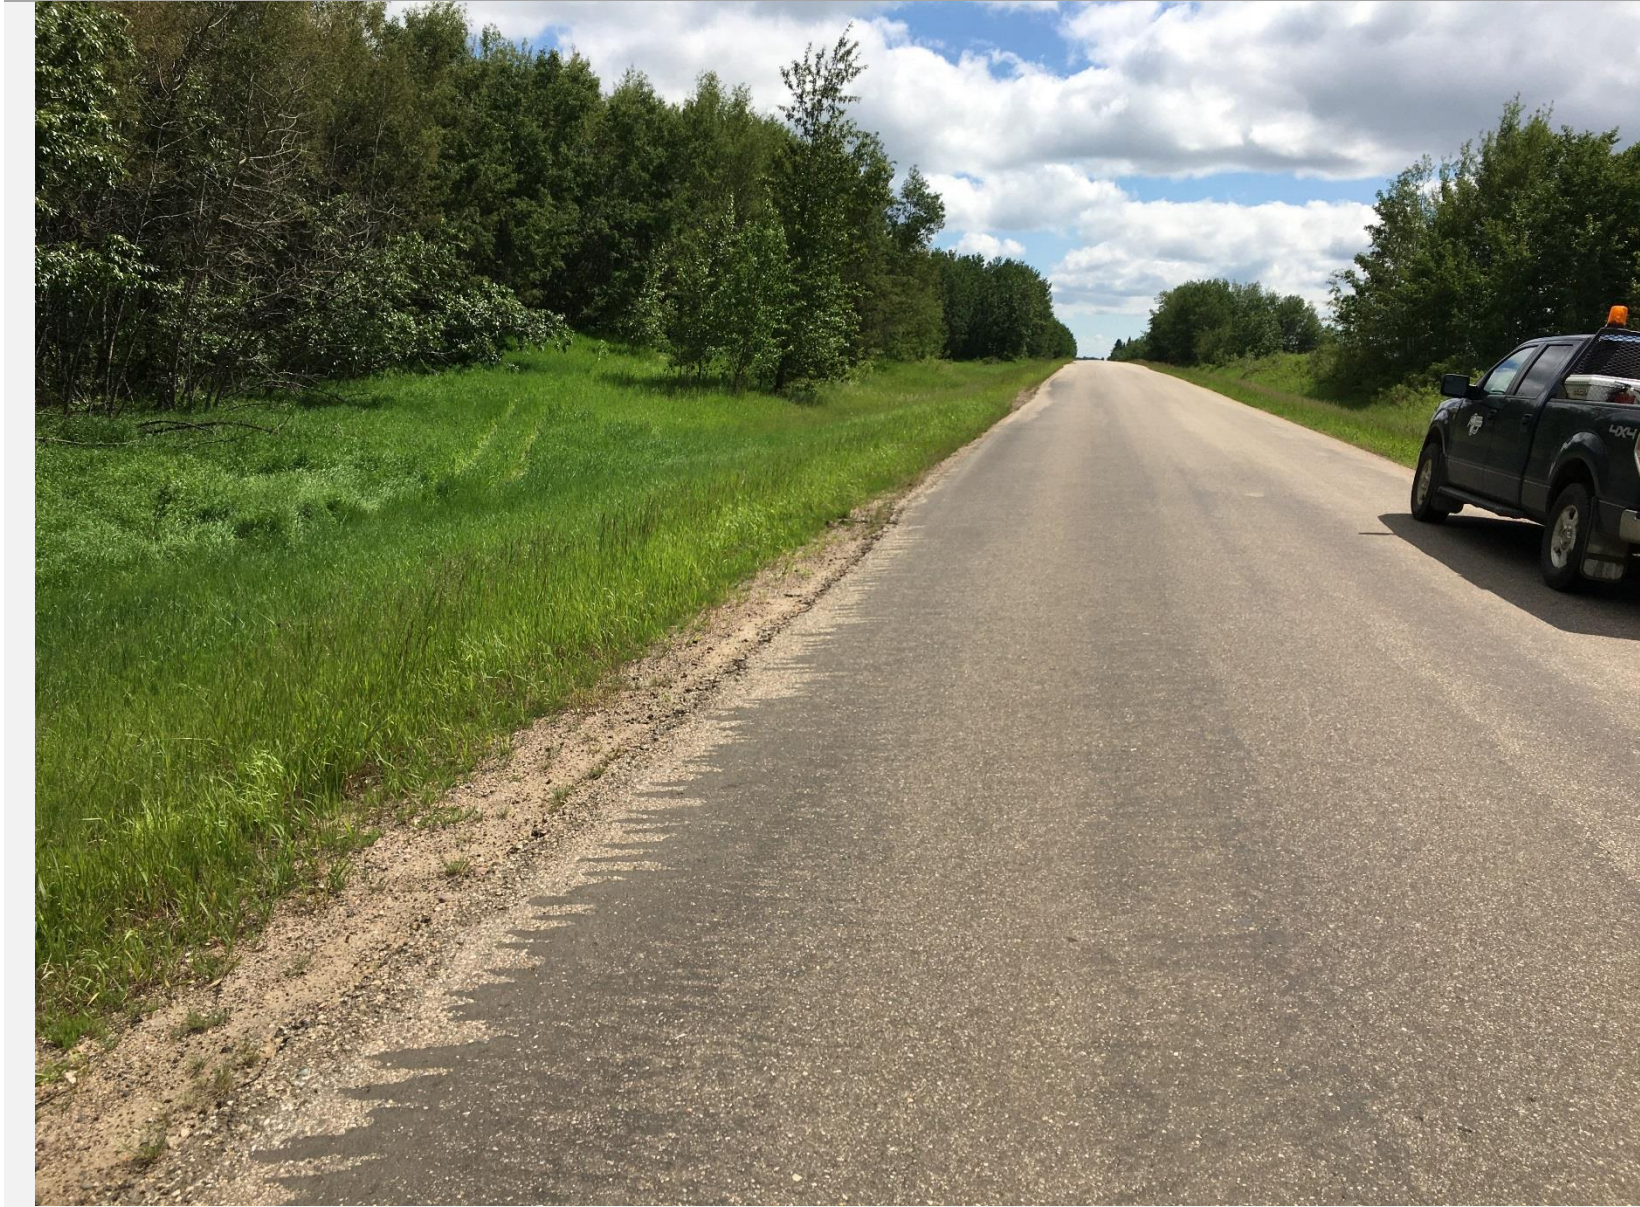
**Photo 14**  
Looking east of  
north ditch at  
surveyed site 1  
TWP Road 512.

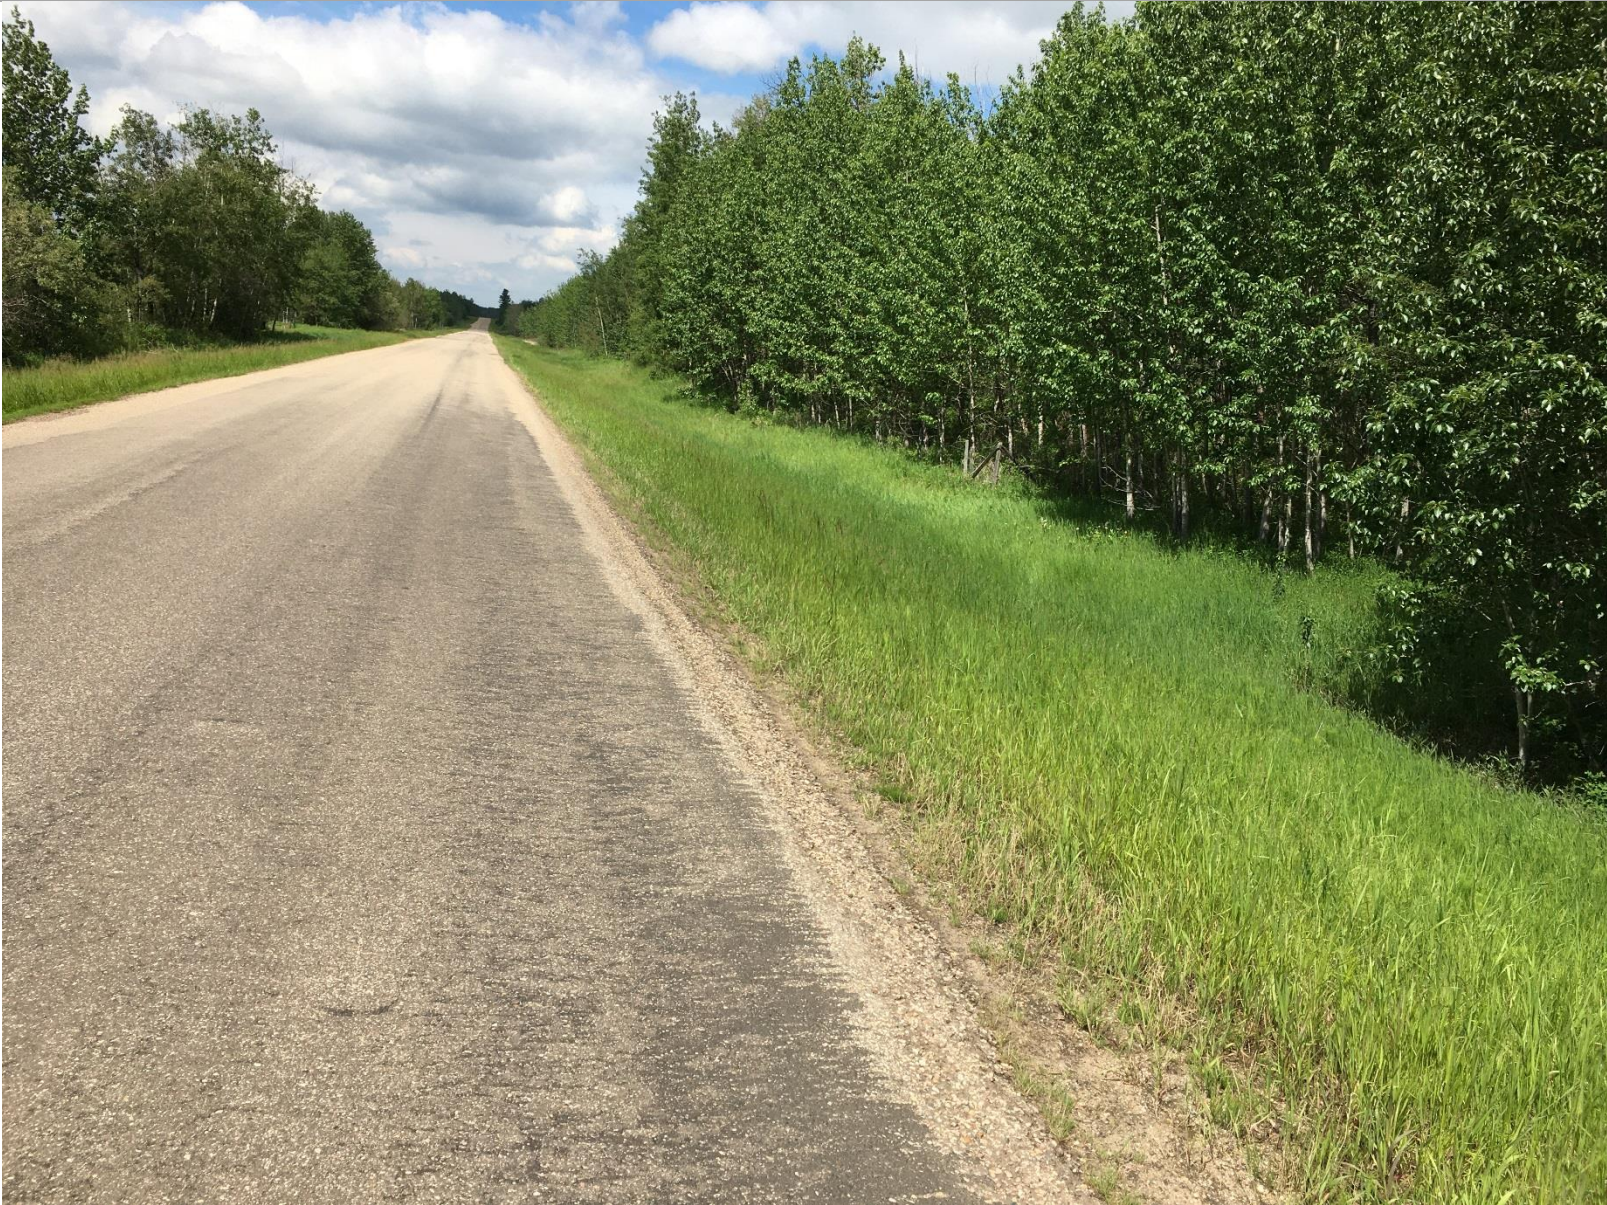
**Photo 15**

Looking west at north ditch at surveyed site 1 TWP Road 512.

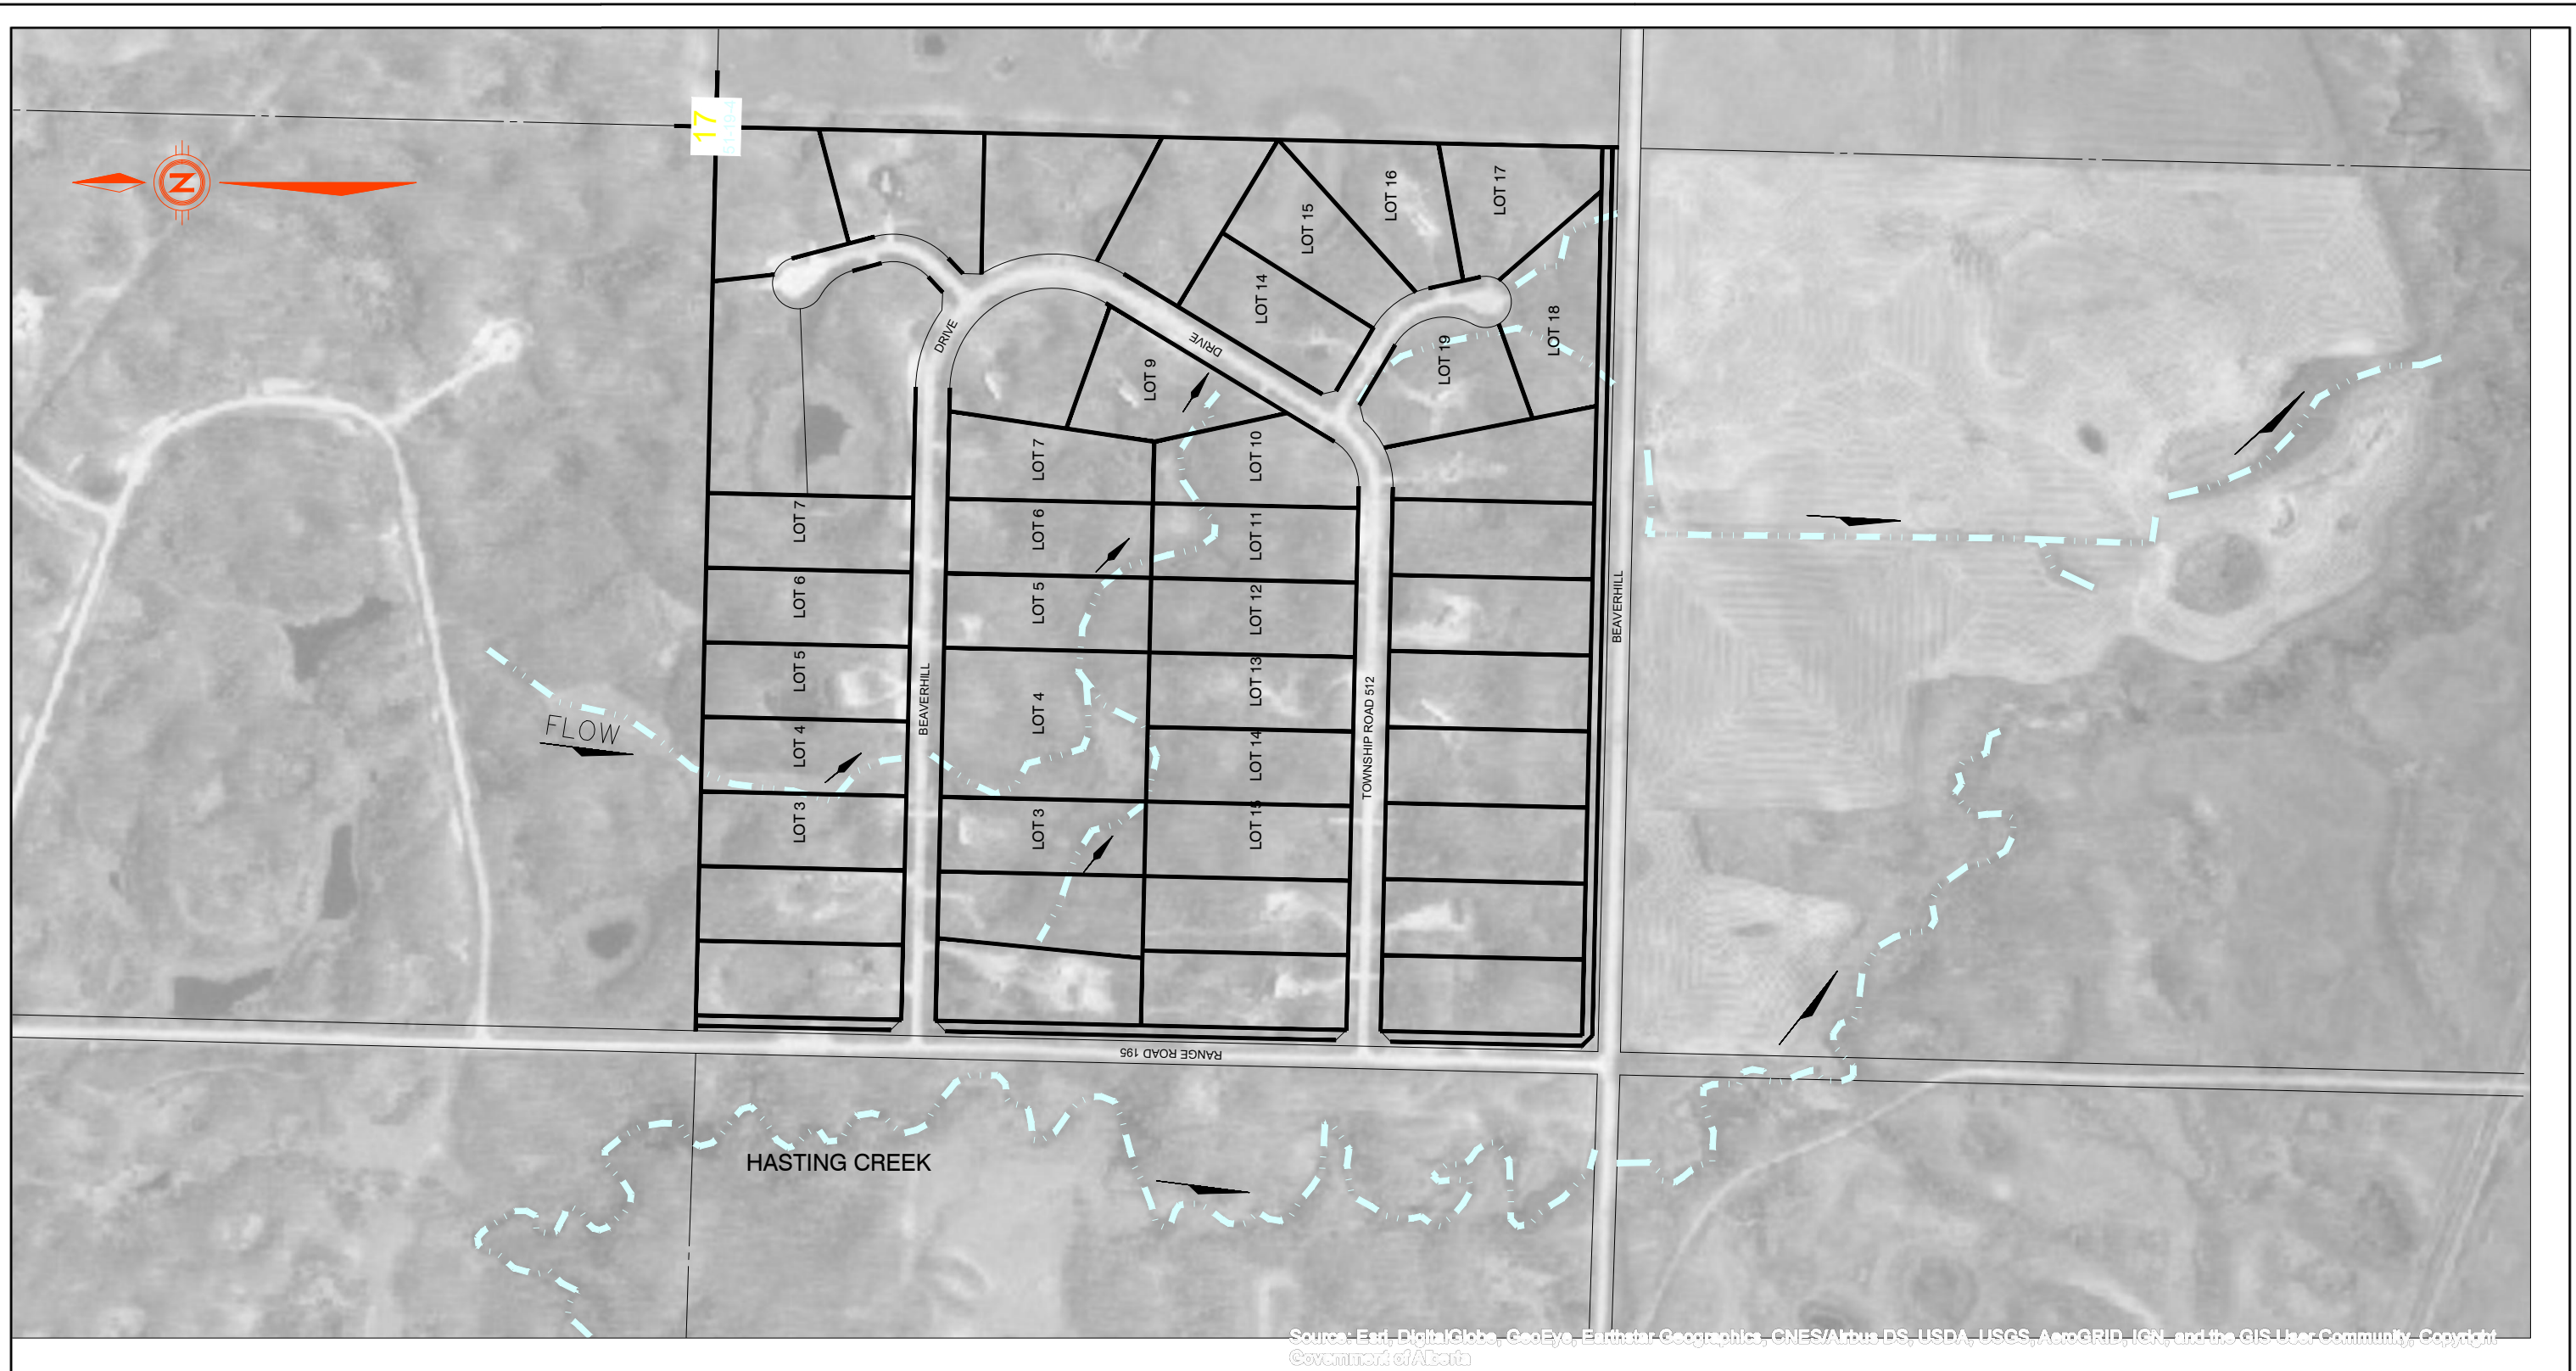
**1980 Air Photo:** Figure 1 given in Appendix B, shows the estimated drainage path as of 1980. This shows that drainage pattern is from the north to the internal subdivision road and through a centreline (CL) culvert to the south to MR. The water flows east across the south side of the MR (Lot #24) and across the center of Lot #30 where it flows into the downstream natural drainage channel. The 1980 air photo shows that Lot #30 was not developed at that time to present grades.

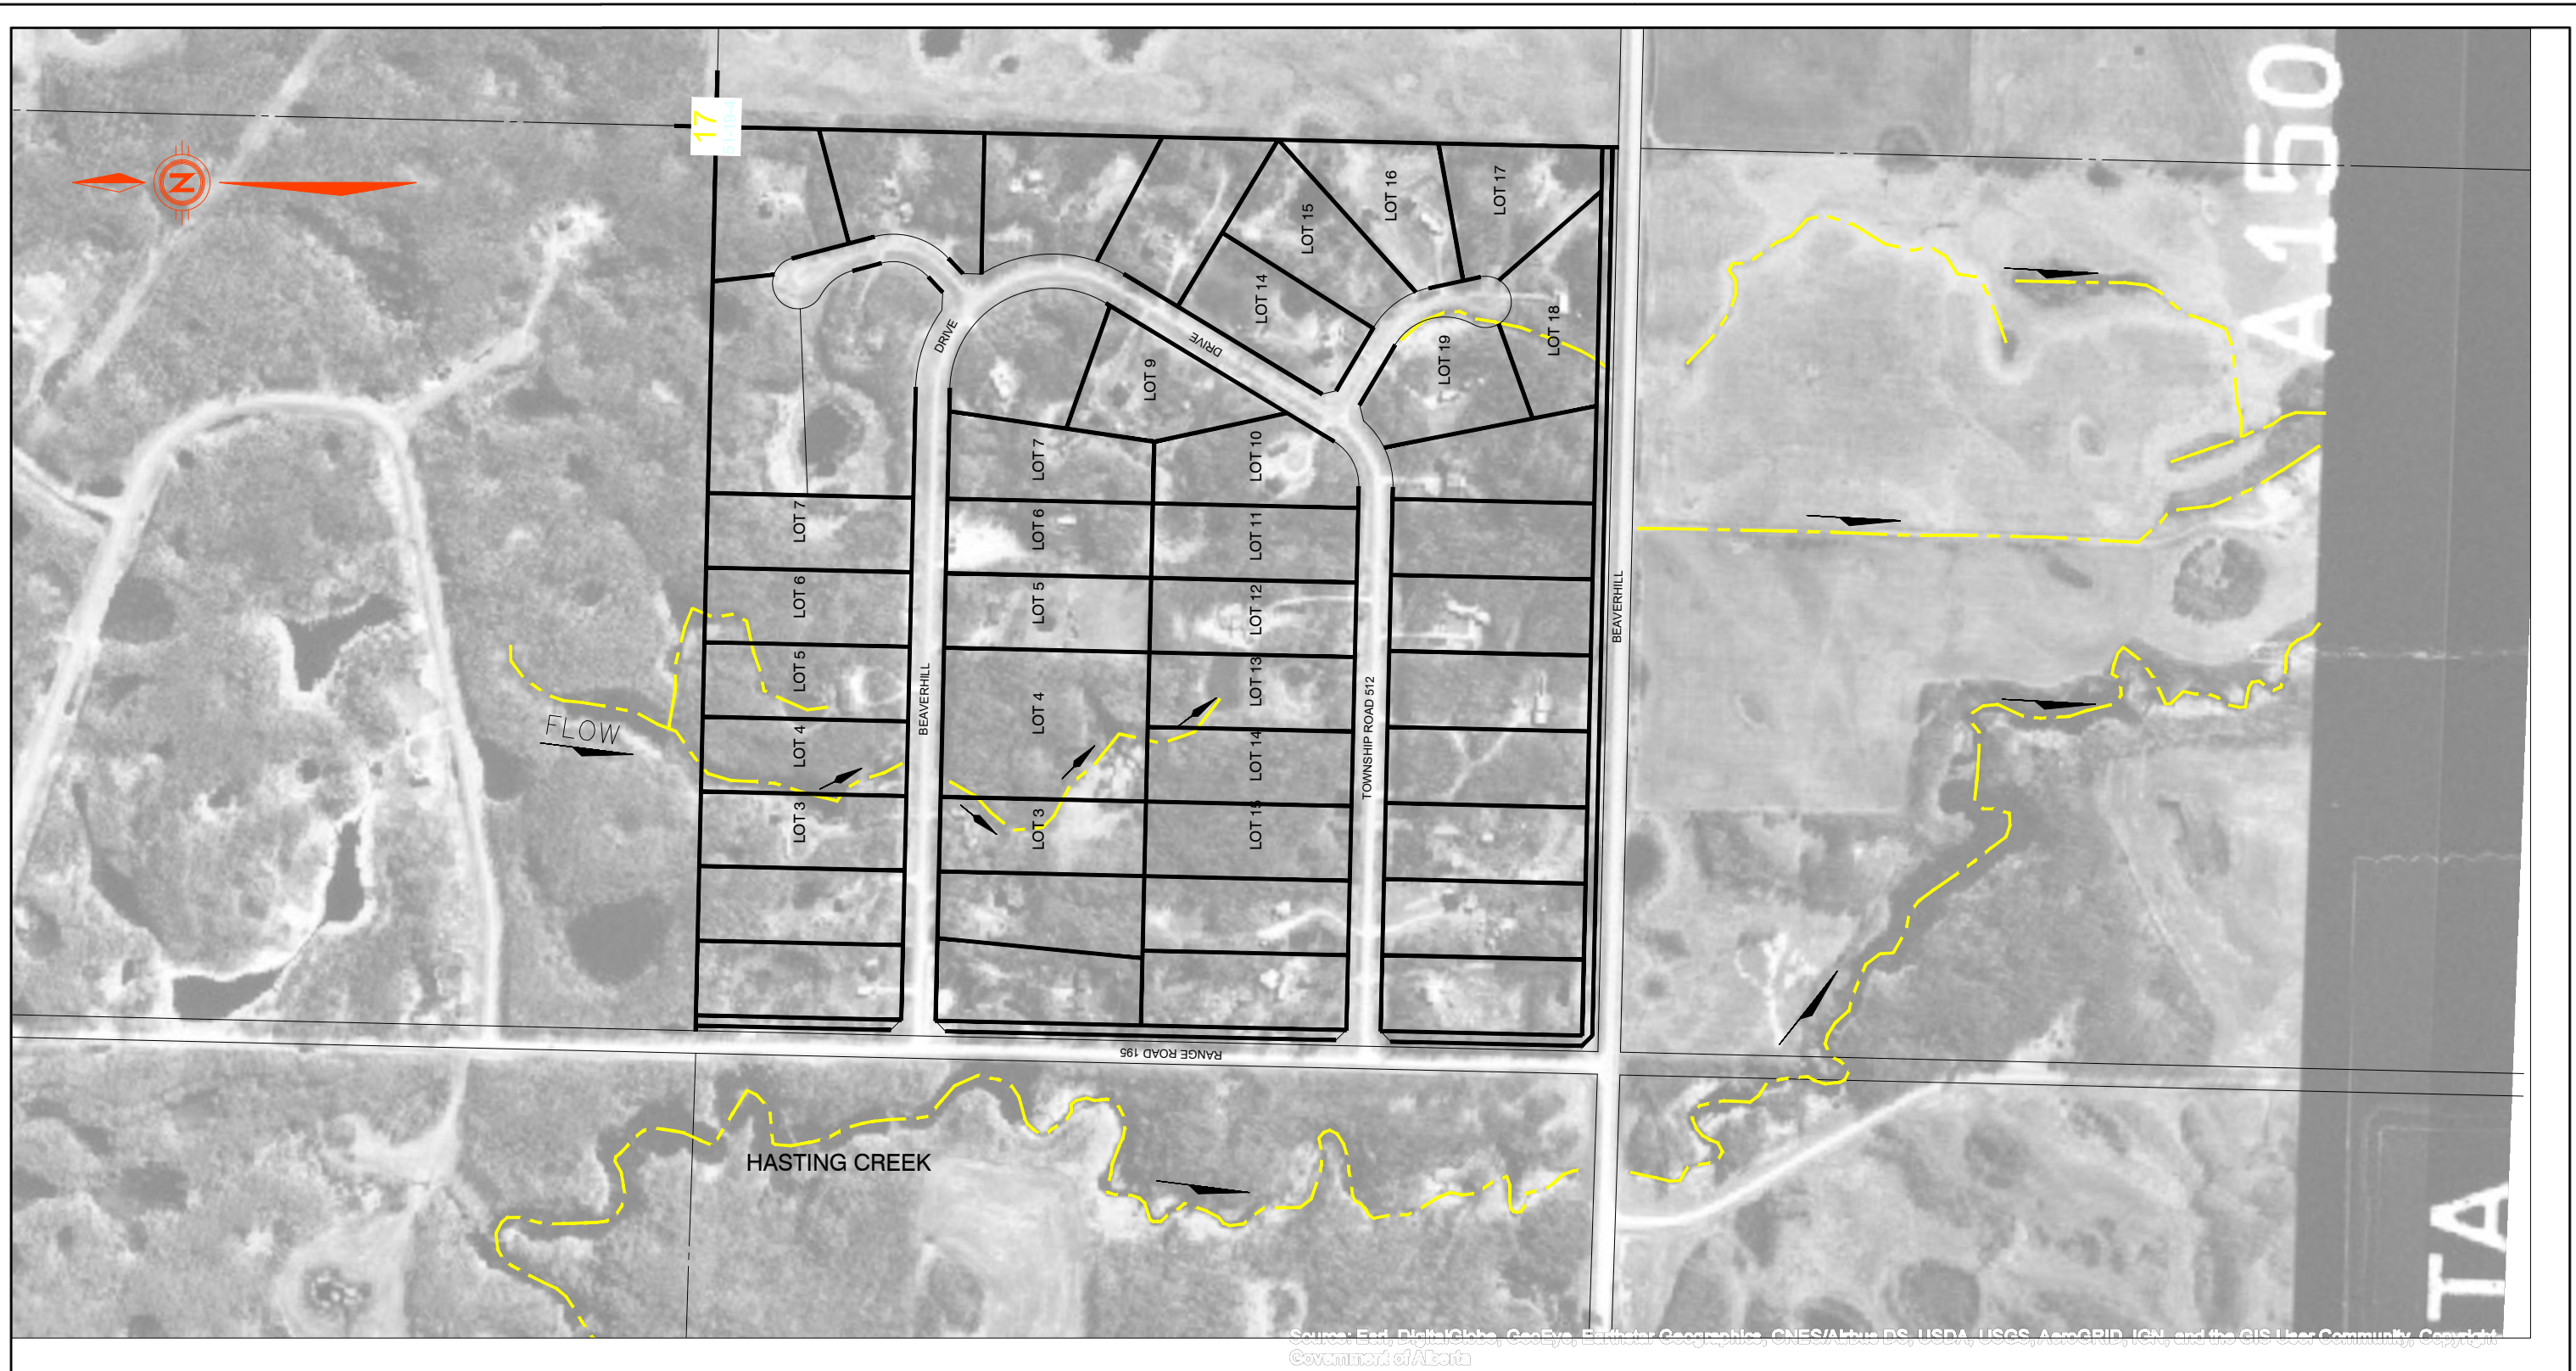
**1993 Air Photo:** Figure 2 given in Appendix B, shows the estimated drainage path as of 1993. This figure shows that the drainage pattern is from the north to the internal subdivision road and through a CL culvert to the south to MR. The water then runs southwest across the west side of the MR Lot 4 in Block 2 (Lot #24) and onto Lot 3 in Block 2 (Lot #18). Based on the 1993 air photo, the water then flows to the south side of the MR Lot 4 in Block 2 (Lot #24) and onto Lot 14 and Lot 13 of Block 2 into a pond. If the pond overflows, the water flows east as shown on figure 2, given in Appendix B. The 1993 air photo shows that Lot 5 of Block 2 (Lot #30) was developed before or at the time of the air photo was taken up to present grades and the natural drainage channel path seems to be blocked in Lot 5 due to this development.

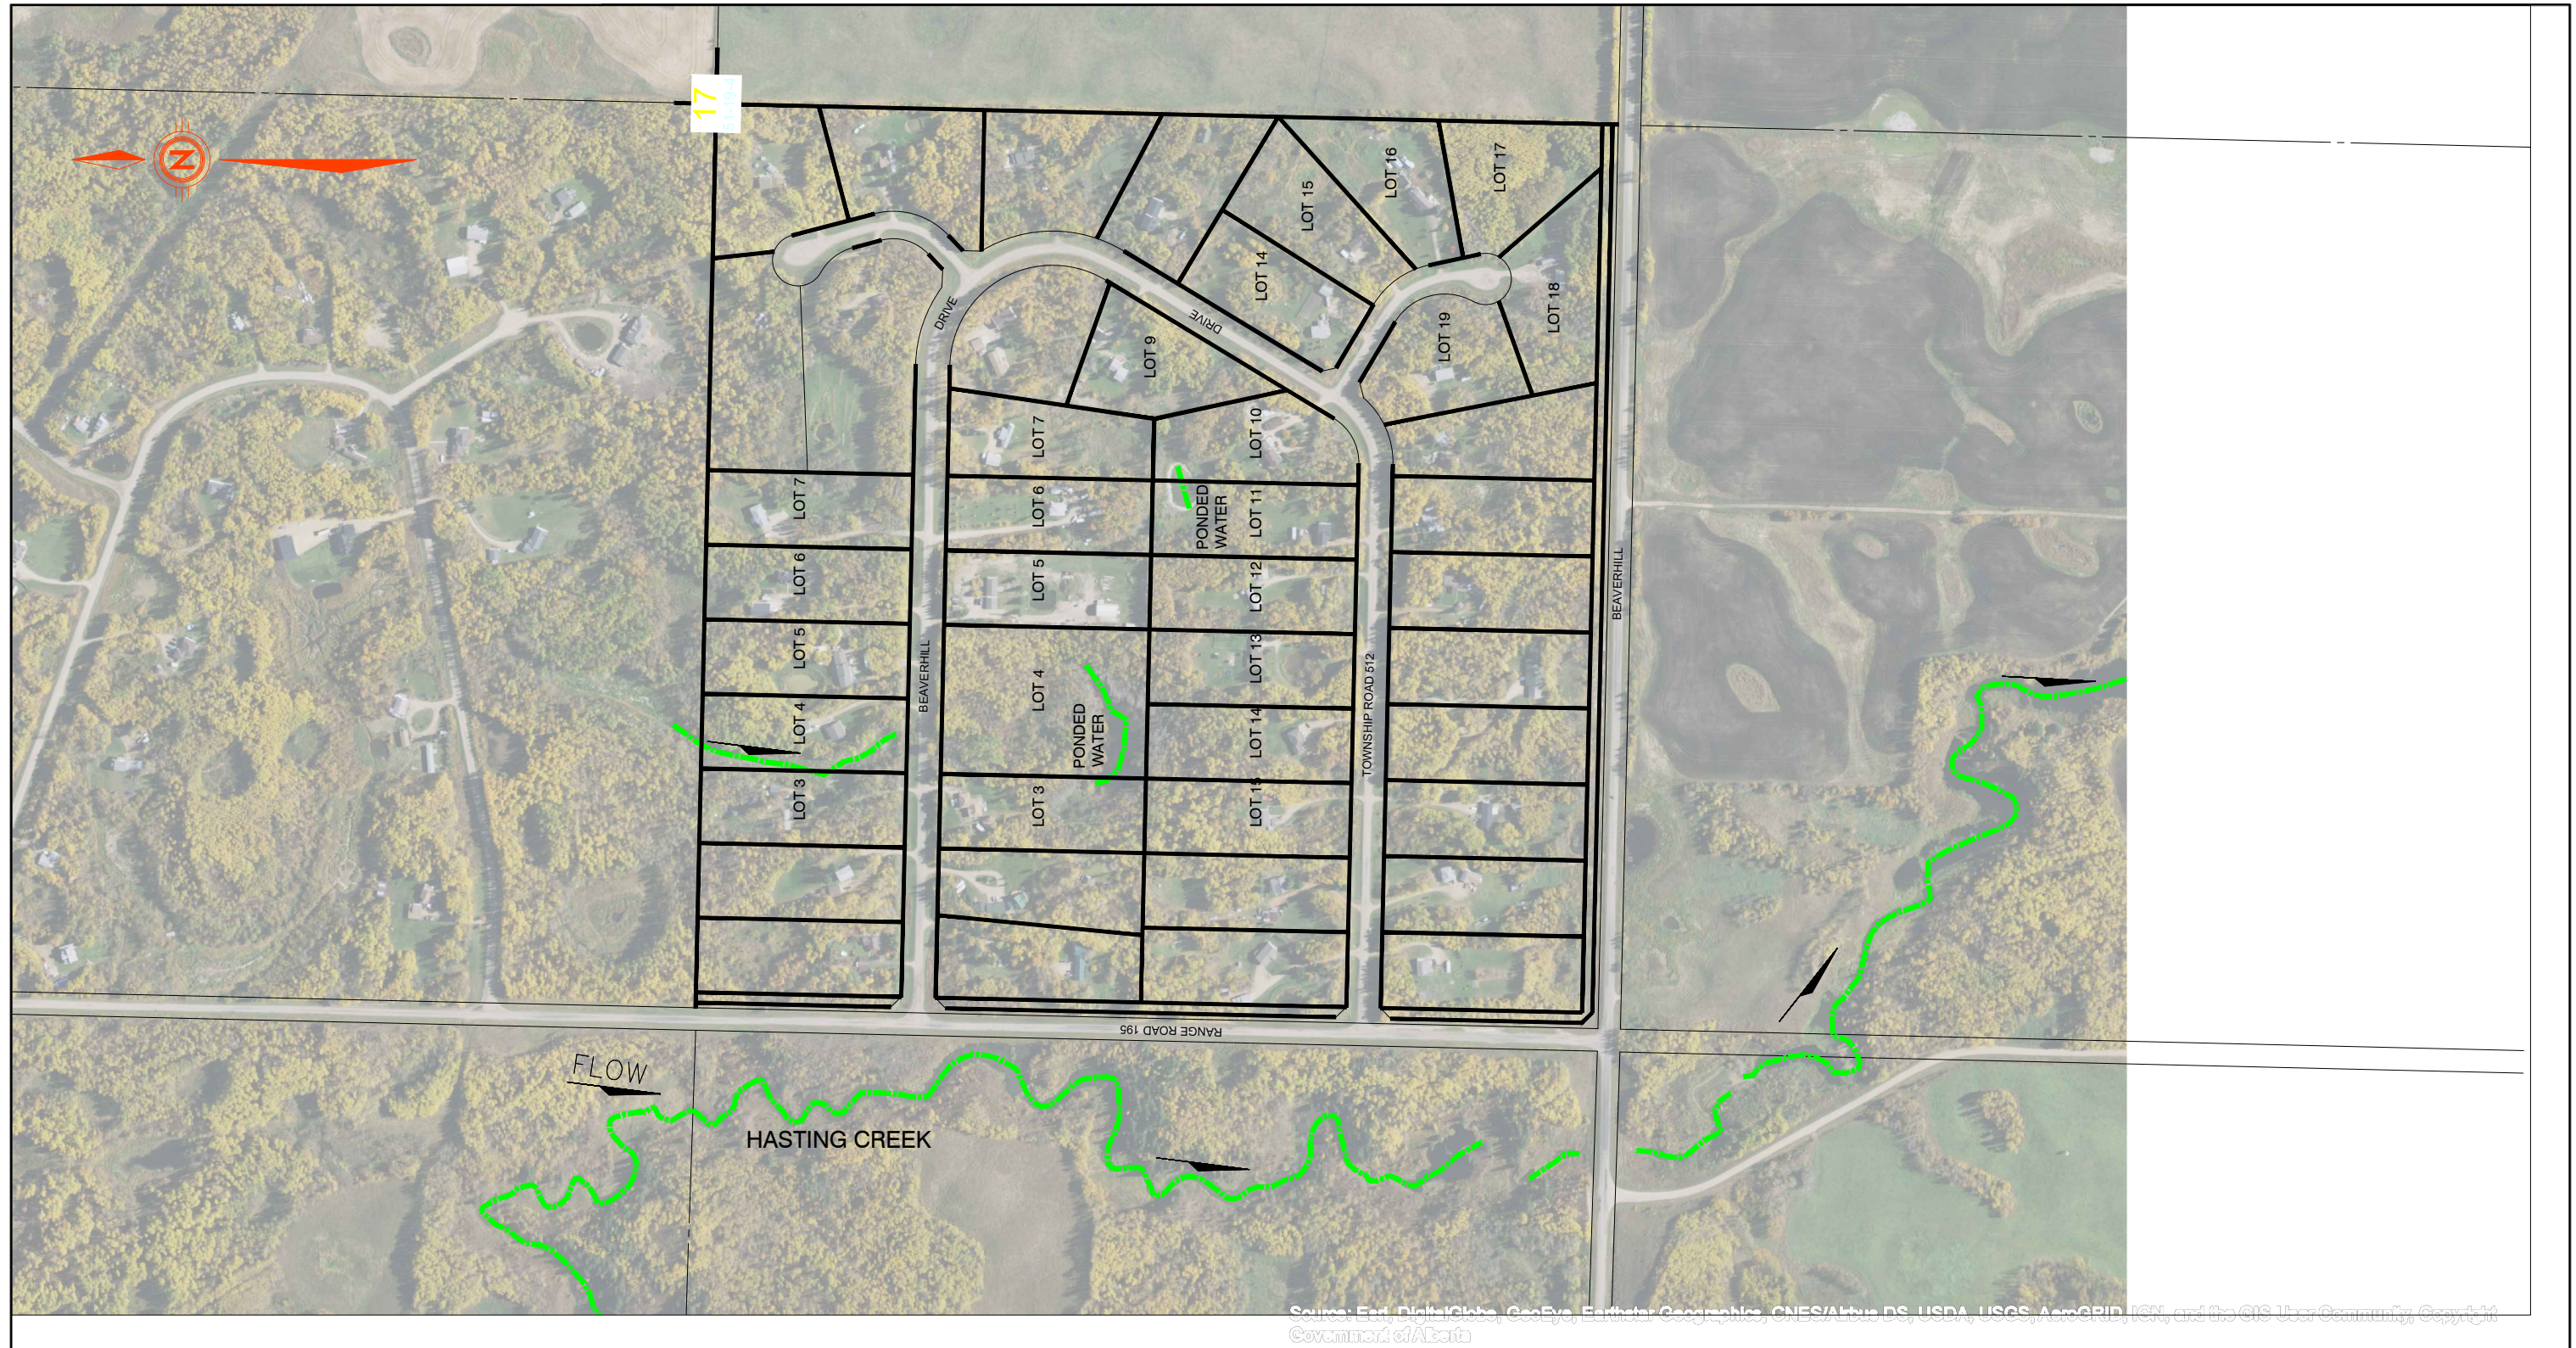
**2017 Air Photo:** Figure 3 given in Appendix B, shows the estimated drainage path as of 2017. This figure shows that the drainage pattern is from the north to the internal subdivision road and through a CL culvert to the south to MR. Beyond that there is no well-defined drainage pattern and water is ponded in MR lot 4 Block 2. There is no well defined drainage pattern within the study area and only ponded water are shown.

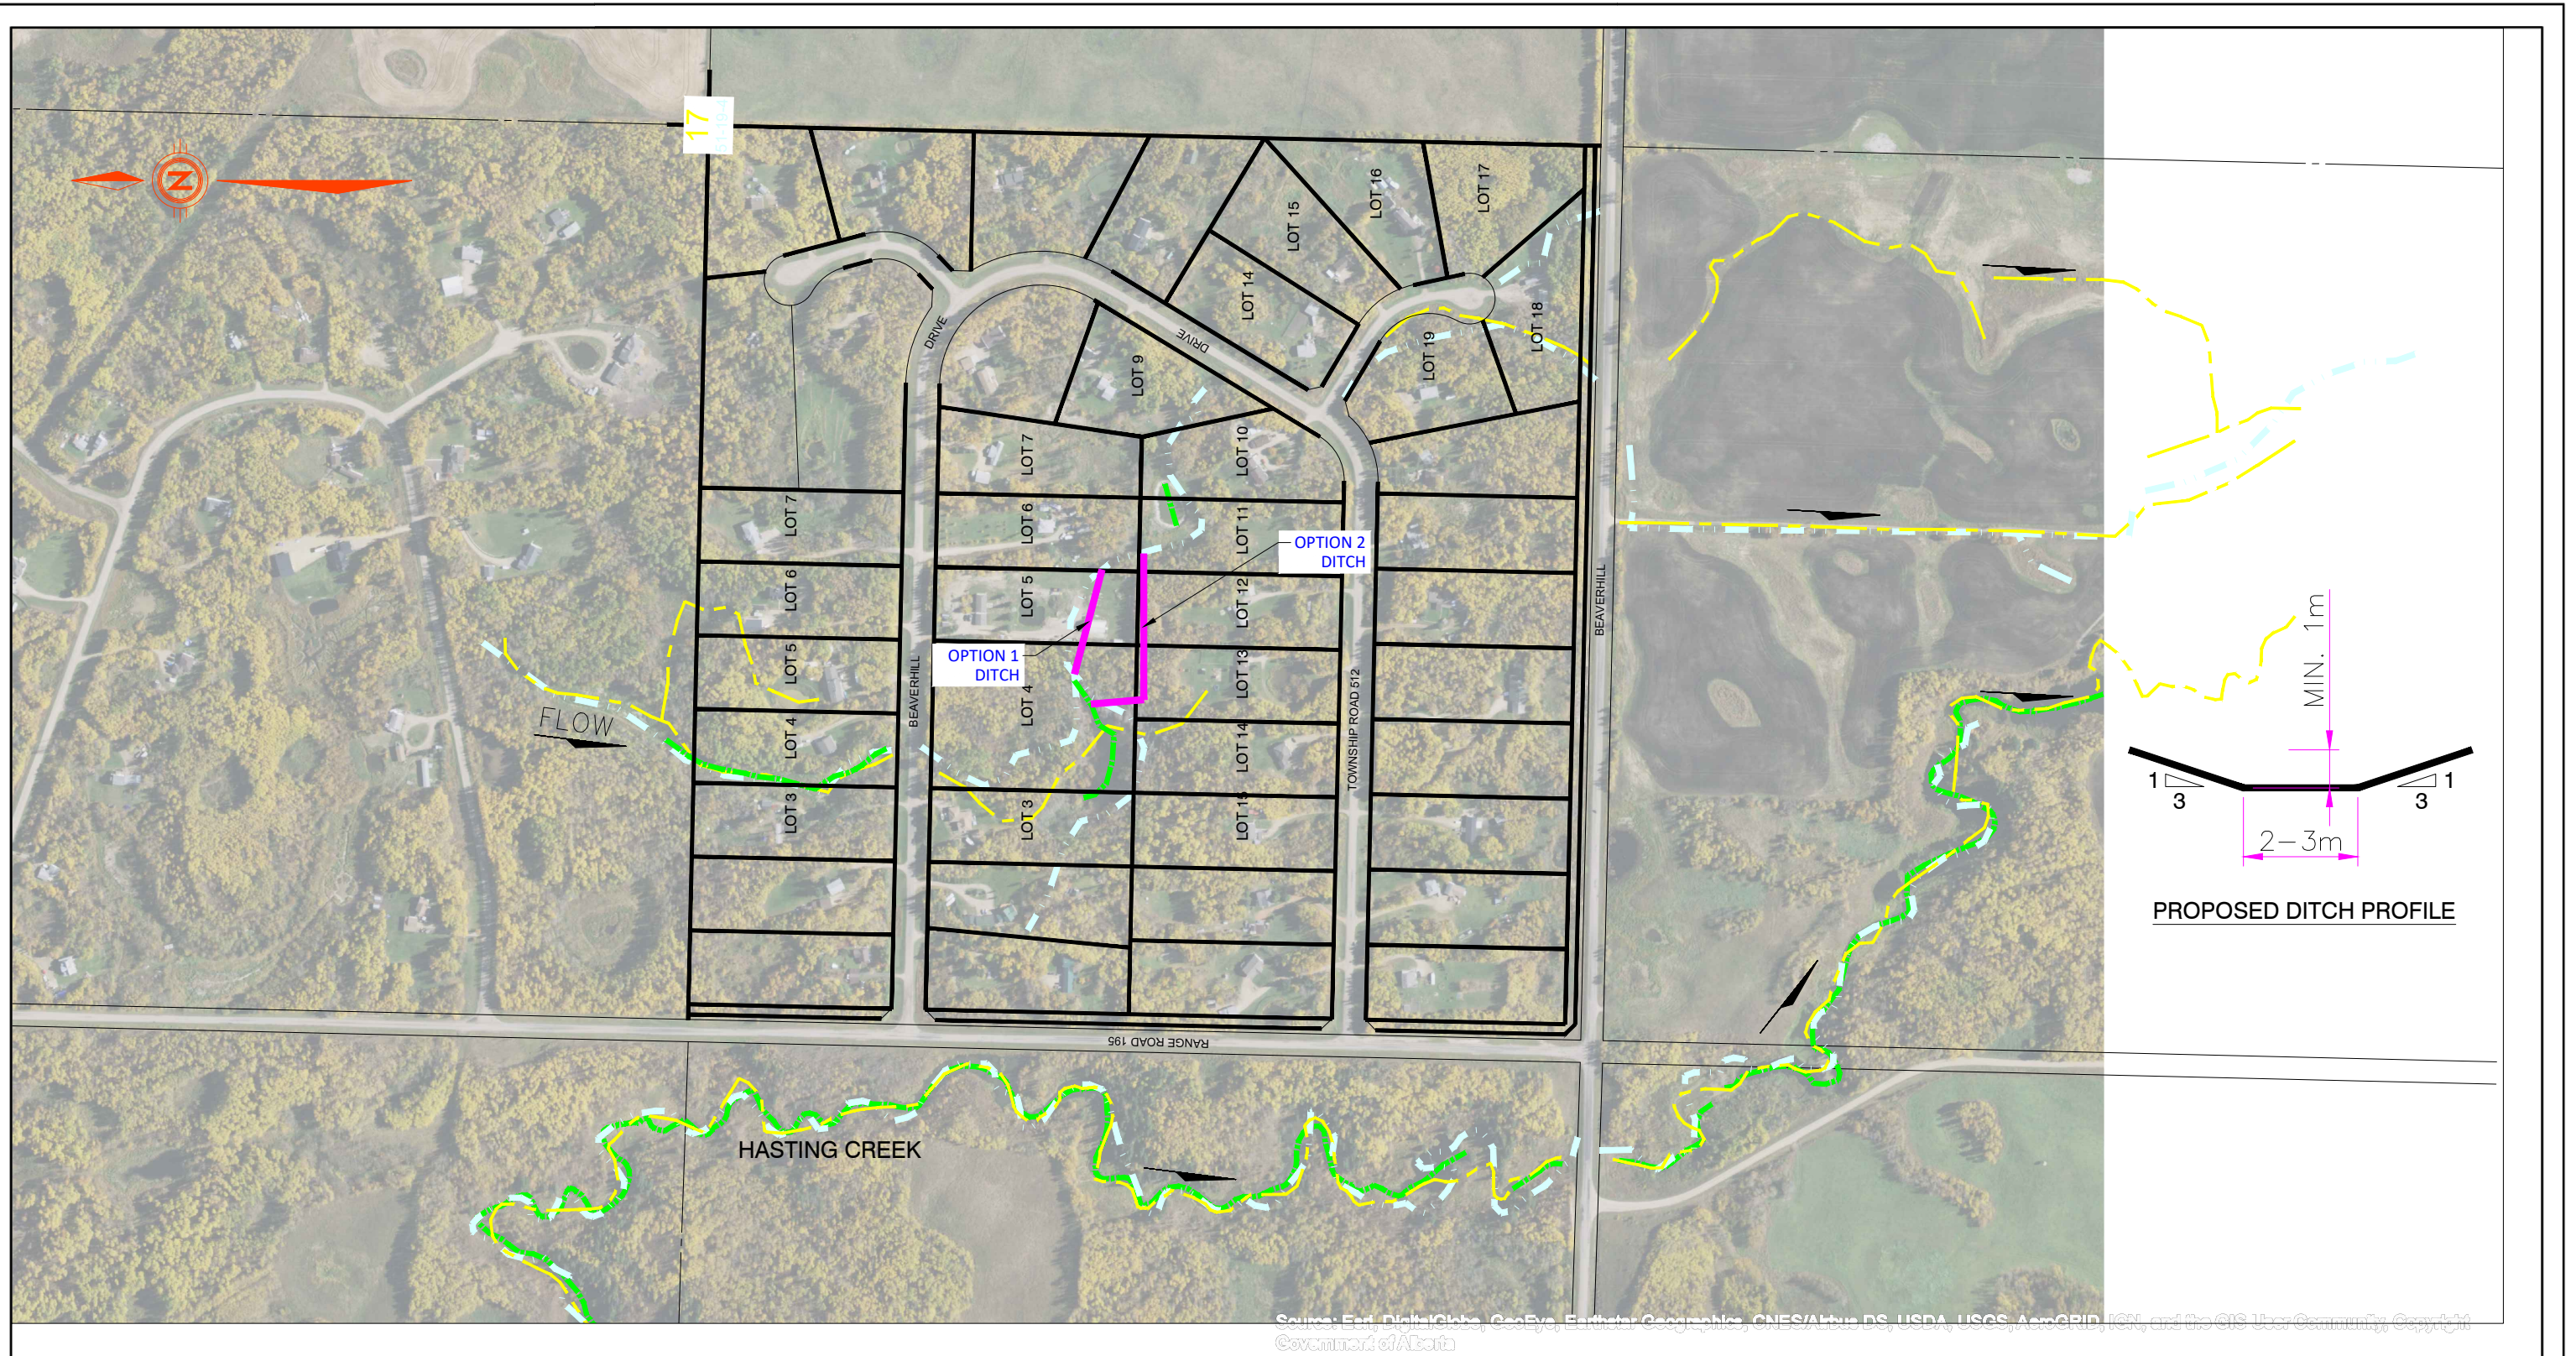
Figure 4, given in Appendix B, provide a comparison of the drainage path for the years of 1980,1993 and 2017. It also shows options for the proposed drainage ditch to maintain flow from MR Lot 4 of Block 2 into the natural drainage path in Lot 6 and Lot 11 of Block 2.

It is suggested to construct the open channel ditch with a minimum 1 m depth, 2 to 3 m bottom width and 3H:1V side slopes. The open channel ditch should be designed to retain the ordinary high water (1:2 year) in MR (Lot 4). The proposed Option 1 and Option 3 ditches profile and their location is shown in Figure 4 given in Appendix B. Figures 1 and 2 given in Appendix E, provides pertinent environmental land features in the study area.

It is recommended to proceed with the detail design of Option 1 (i.e. construct a drainage ditch from MR (Lot 4) to natural drainage path in Lot 6 through Lot 5 along the historical drainage path) since Option 1 would provide the shortest drainage path along the historical natural drainage path with the smallest footprint than Option 3. Option 1 is also preferred over Option 2 since its maintenance would be easier. An agreement with the current landowner would be required for the recommended Option 1.
