July 31, 2020  
Wood Project No.: ET200020

**Reference: Lindbrook Estates Subdivision  
Drainage Assessment Report  
Beaver County**

**June 20, 2020 Site Visit Photos**

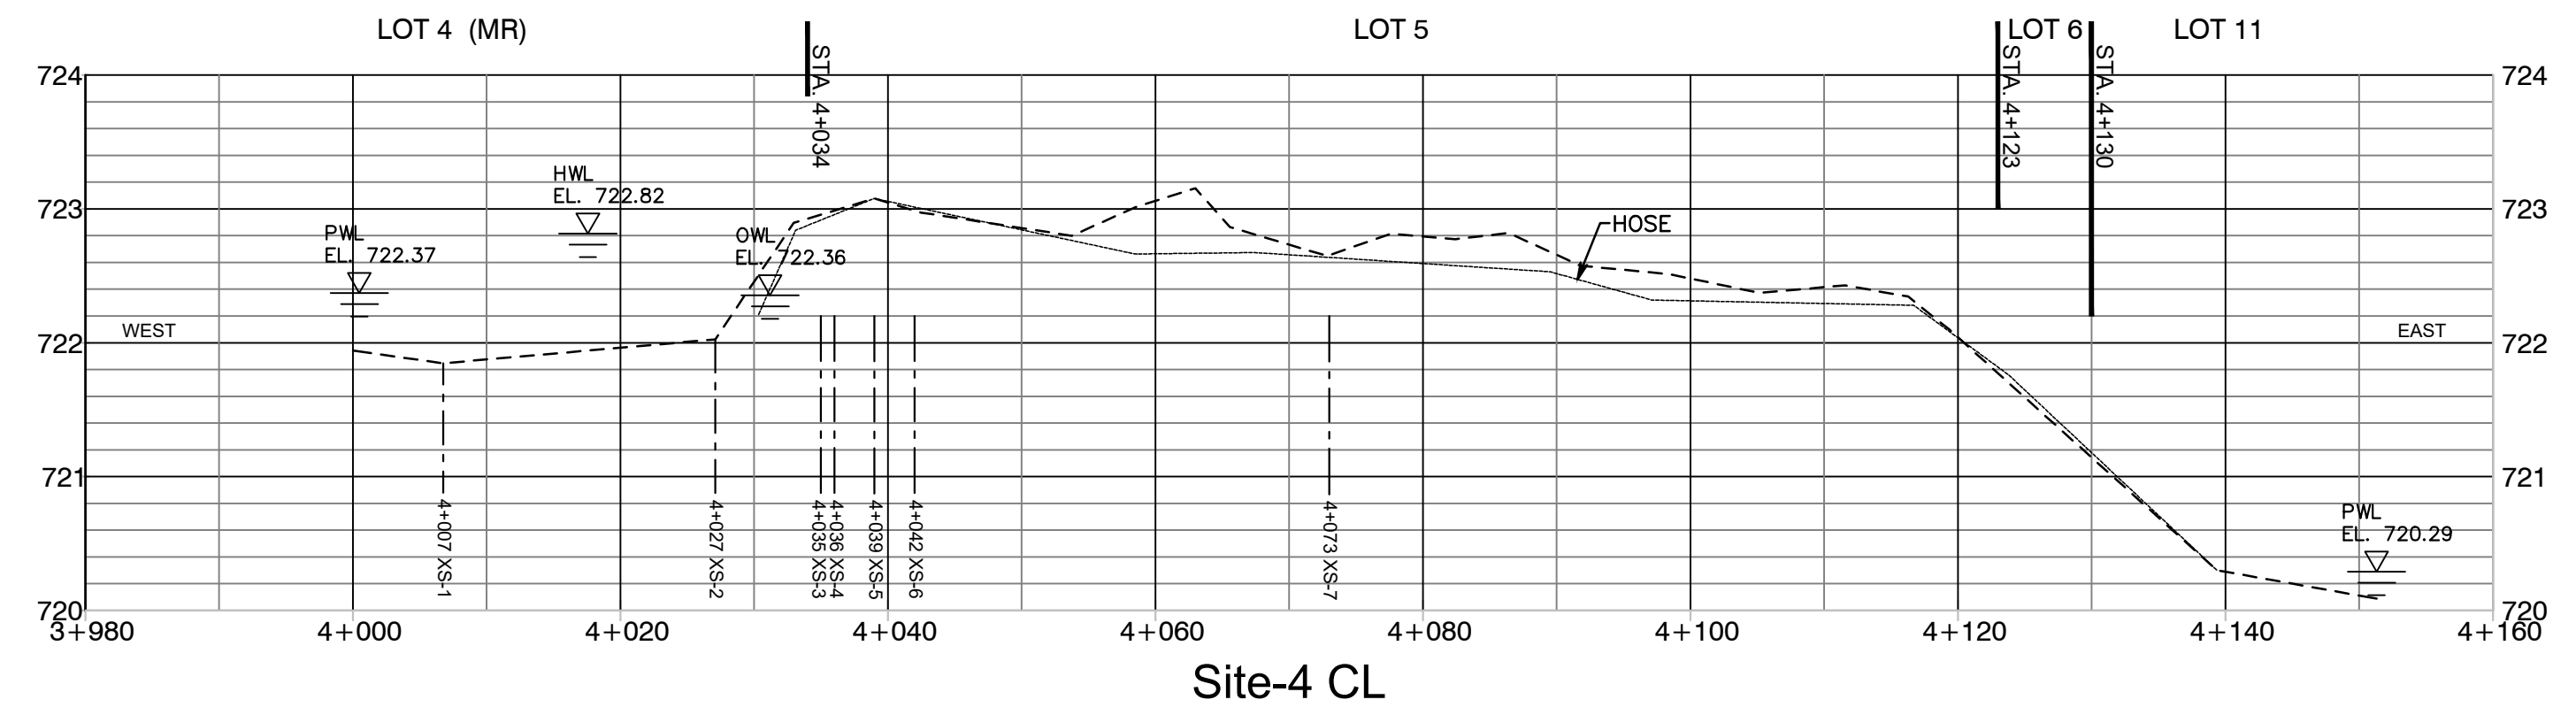
Site-4 CL

- south into MR. The 600mm diameter X 17 m CSP culvert invert elevations are; N Inv 724.28 and S Inv 723.93.
- Site 4 - Site 4 survey provides a plan and profile along the hose (being used for pumping of water) from MR (Lot 4) through Lot 5 into Lot 6 and Lot 11 existing natural drainage path. Site 4 profile shows that the ponded water level in MR is 722.37 and in the natural drainage path in Lot 11 it is 720.29. This provides a slope of 1.7%. The profile also shows high ground between MR (Lot 4) and Lot 5 at an elevation in the order of 723.1, which provides a berm height in the order of 0.9 m between the two properties. The water is currently being held back at the property line between Lot 5 and the MR (Lot 4).

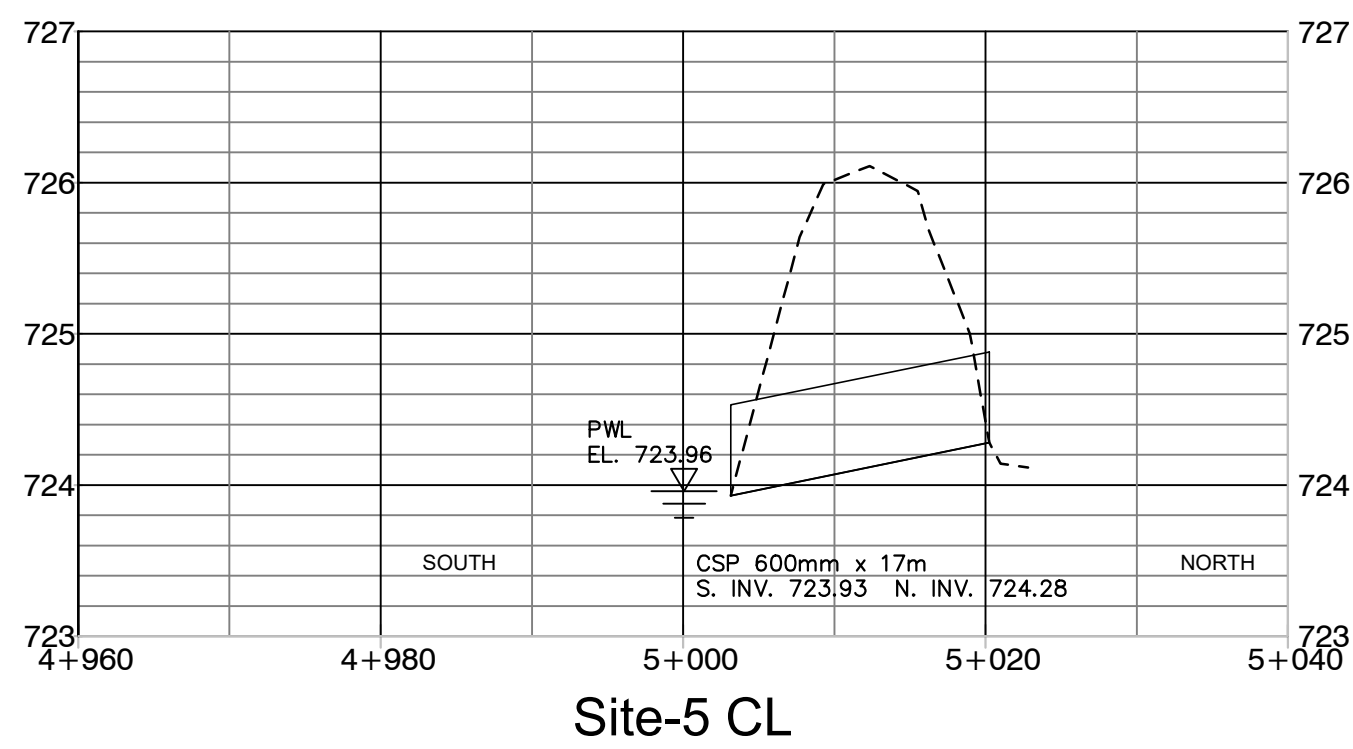
Site-5 CL

- Site 5 - Site 5 survey provides the roadway profile and CL culvert inverts draining from north to

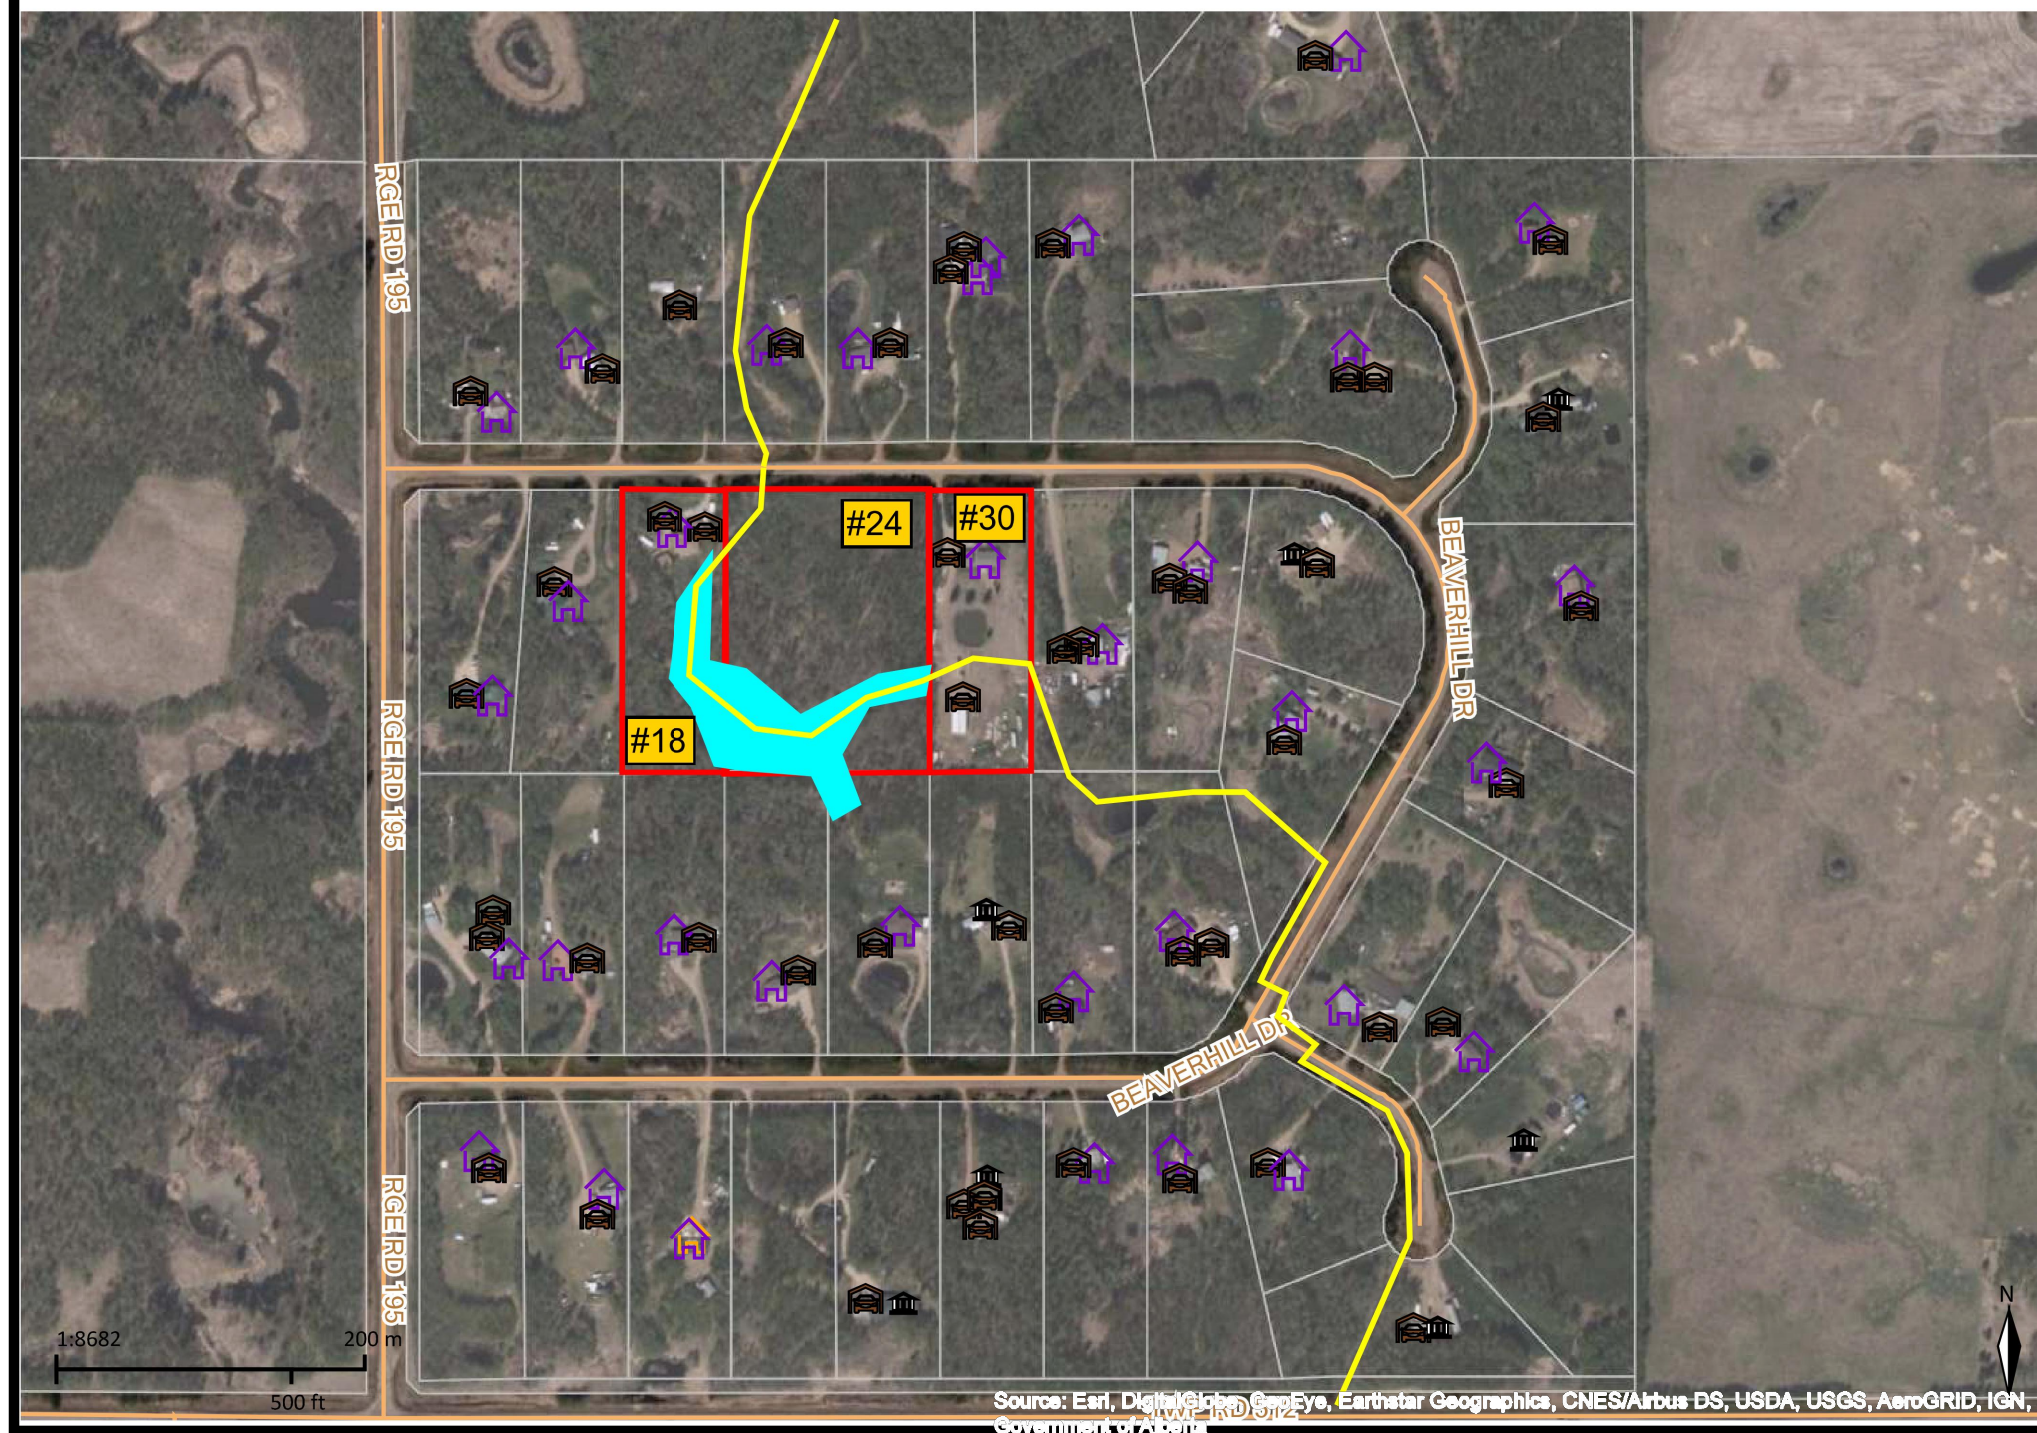
As shown on the plan given in Appendix D provided by the County, the existing drainage pattern is from the north to the internal subdivision road and through a CL culvert to the south to MR at site 5. Due to 0.9 m high berm between MR (Lot 4) and Lot 5, the water is ponded in MR and backs up across the west side of the MR Lot 4 (Lot #24) and onto Lot 3 (Lot #18). Based on our review of historical air photos, the water should flow east across the south side of the MR Lot 4 (Lot #24) and across Lot 5 (Lot #30) to the existing natural drainage channel in Lot 6. Presently during high flooding due to excessive rains, drainage water is diverted to the existing natural drainage path in Lot 6 through a pump and hose arrangement from where that drainage path runs east to the internal subdivision road again. From there, it runs south through one approach, under the road and down to the cul-de-sac at the south east end of the subdivision before running under Township (TWP) Road 512 and south to the Hastings Creek.
