July 31, 2020  
Wood Project No.: ET200020

**Reference: Lindbrook Estates Subdivision  
Drainage Assessment Report  
Beaver County**

**June 20, 2020 Site Visit Photos**

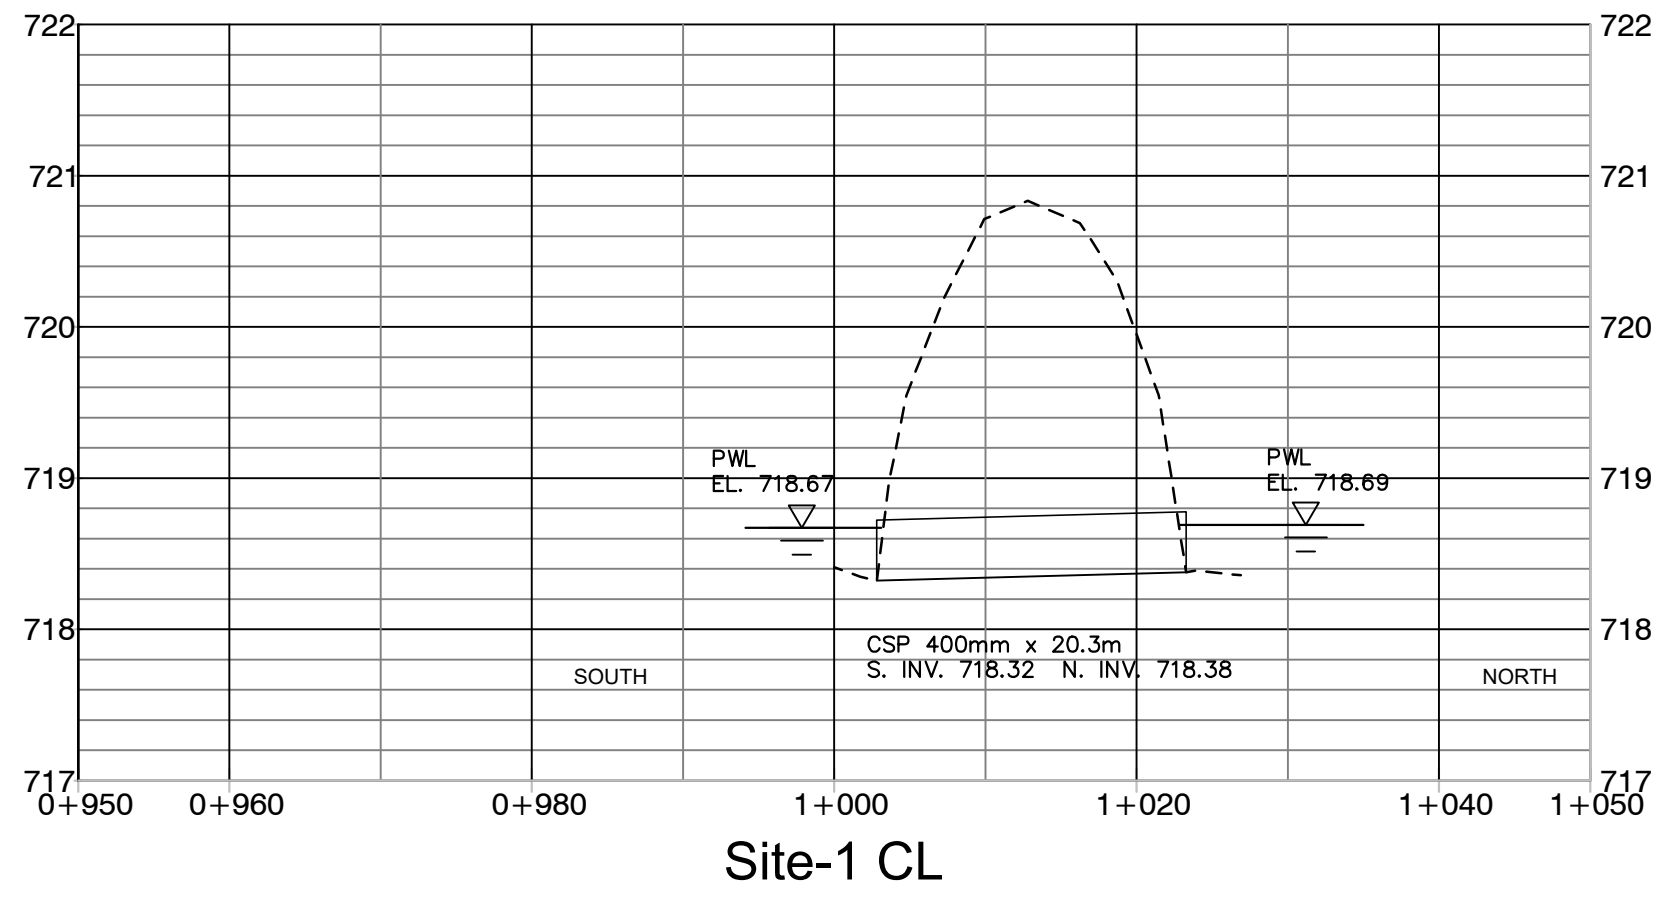
Site-1 CL

for surveyed sites 1, 2 and 5. See Appendix C for details.

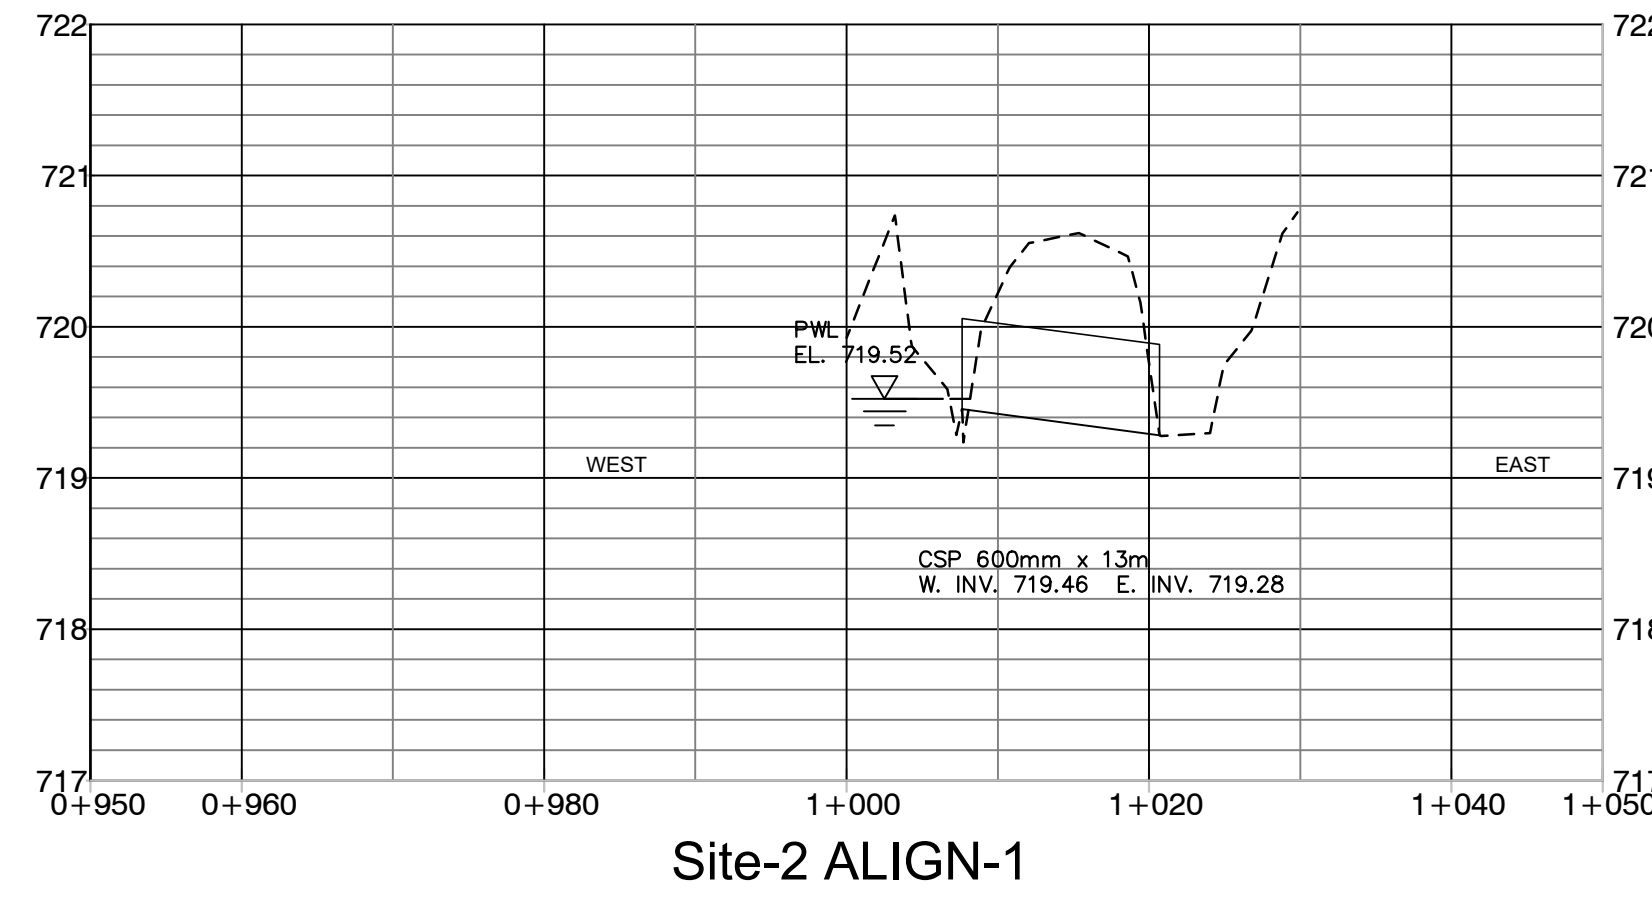
Site-2 ALIGN-1

The drainage system from the surveyed site 2 downstream up to the surveyed site 1 (400 mm in diameter culvert under TWP Road 512) including ditches, CL culverts and approach culverts are not functioning well and should be further investigated. In general, in these areas, clearing, repair of blocked/damaged culverts and clearing and regrading of the ditches is proposed to maintain drainage flow until further drainage

It is recommended to conduct adequate survey to design this proposed ditch to divert flows from MR Lot 4 through Lot 5 into the natural drainage path in Lot 6. It is also recommended to conduct detailed drainage assessment of the area from surveyed site 2 downstream up to surveyed site 1 (400 mm culvert under TWP Road 512) including ditches, CL culverts and approach culverts.
